Freeze-up, breakup, and winter ice observations on four small regulated and unregulated streams in Newfoundland, Canada

Although winter ice processes are well documented in large, low-gradient rivers, only a few studies on smaller, steeper streams have been published, and none compare regulated environments to unregulated ones. This paper documents the ice conditions observed on two regulated and two unregulated, wadeable streams in south-central Newfoundland from October 2010 to May 2011. Ice conditions were observed using 16 remote camera stations at eight salmonid spawning sites along West Salmon River, Twillick Brook, Compensation Creek, and another unnamed creek. The West Salmon River and Compensation Creek are both regulated streams, while Twillick Brook and the unnamed creek were chosen as potential (unregulated) reference sites.

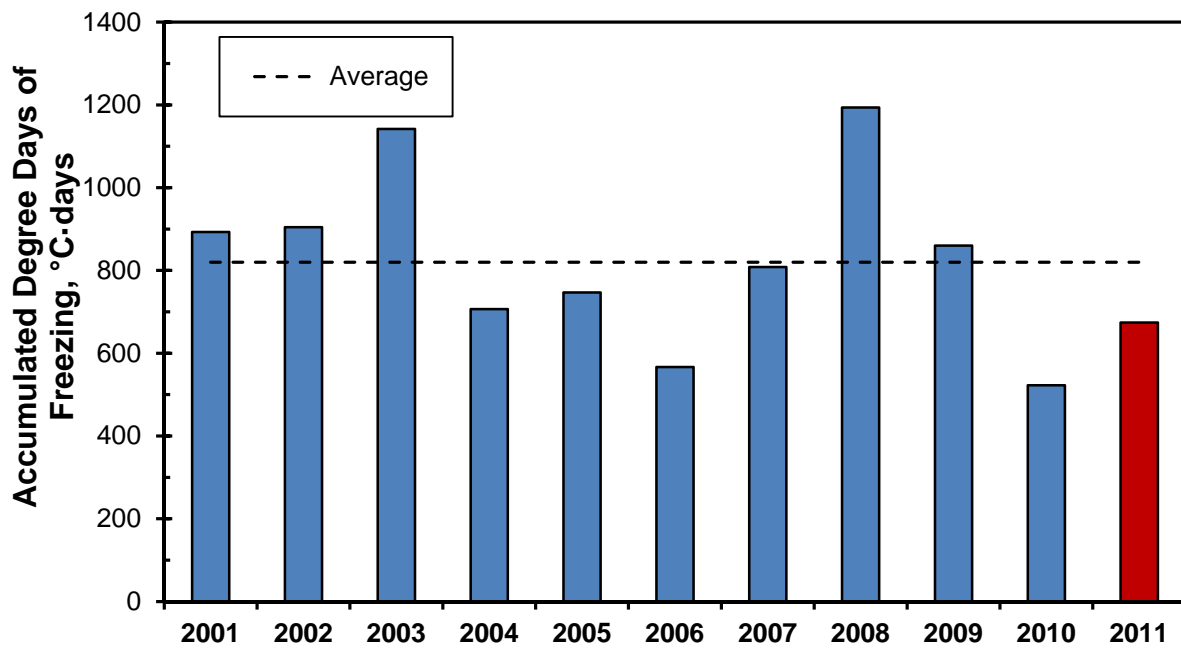
Figure 2. Maximum accumulated degree days of freezing at Badger, NL.

Water Survey of Canada streamflow gauges or Environment Canada (EC) meteorological stations. The nearest EC meteorological station is located at Badger, NL (~100 km from study areas), while the closest EC meteorological station with consistent snowfall data is Gander, NL (~125 to ~180 km from study areas). Based on the data from these stations, in 2010-2011 central Newfoundland experienced a relatively warm winter (seasonal maximum accumulated degree days of freezing below the 10 year average) and received an average amount of snow (Figures 2 and 3). In this study, accumulated degree days of freezing were calculated from the first instance of mean daily temperatures $\leq 0^{\circ}\text{C}$, as multi-day periods of freezing were not observed until after ice had begun to form on the streams. Likewise, accumulated degree days of thaw were calculated from the first mean daily temperature $>0^{\circ}\text{C}$, as spring temperatures fluctuated frequently at Badger.

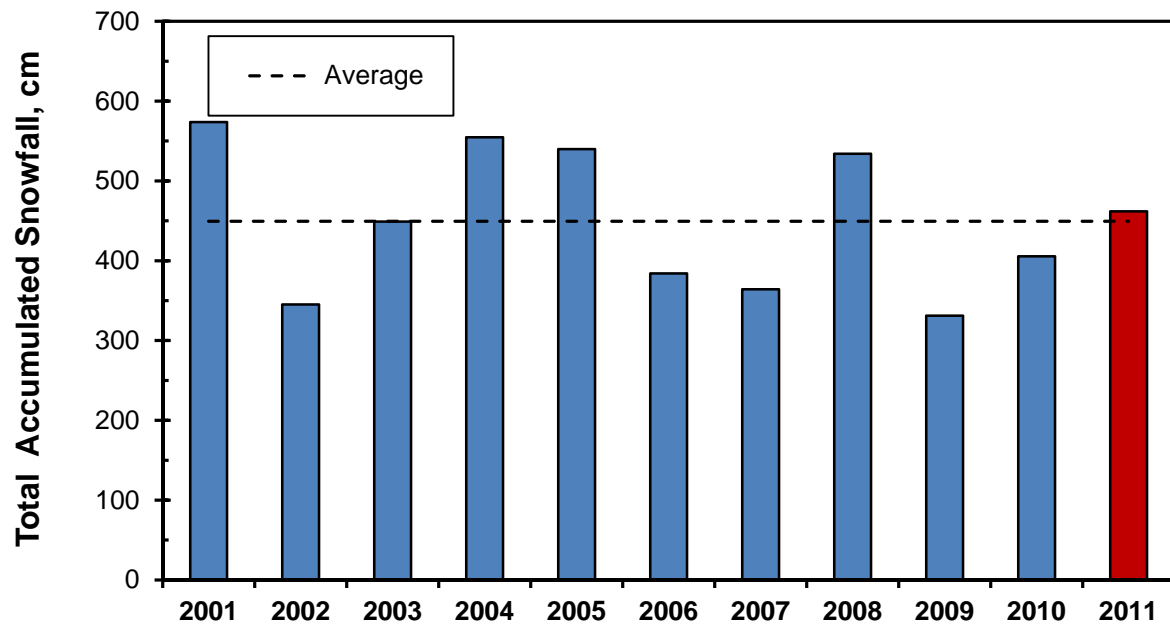
Figure 3. Total accumulated snowfall at Gander, NL.

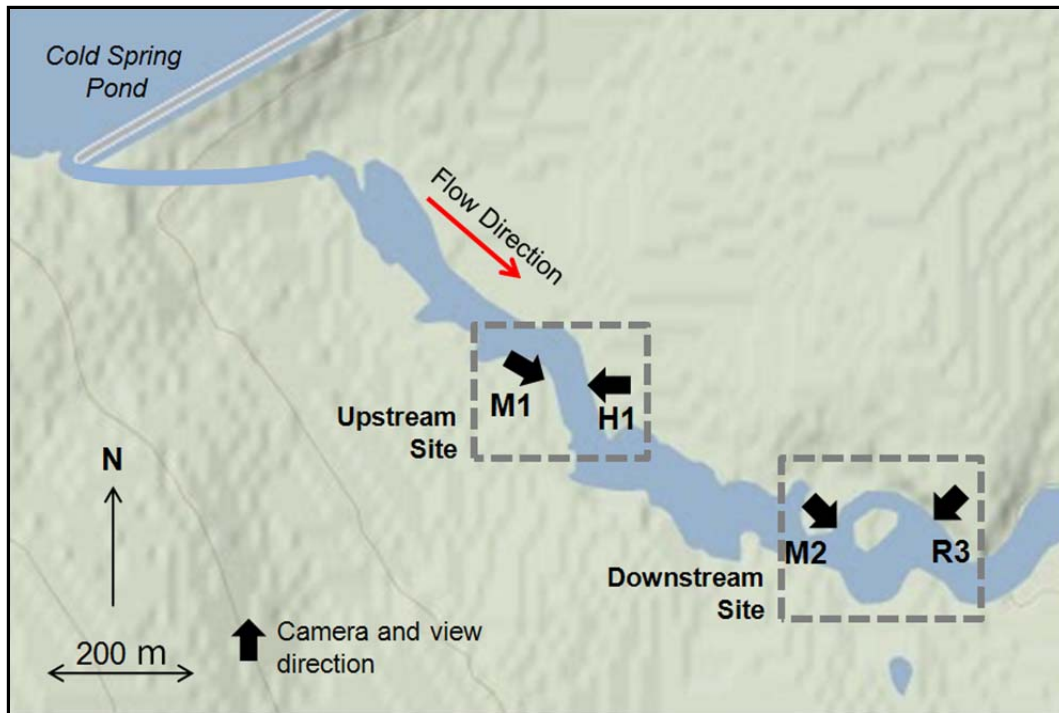
Figure 4. Location of the study sites on the West Salmon River, including camera deployment locations (base image source: 2011 Google Terrain map).

Two streams were studied in the Upper Salmon area. The West Salmon River (Figure 4) is the regulated stream in the study area. Flow to the stream is released from Cold Spring Pond via a control gate which releases a constant outflow of 2.6 m³/s from 1-Jun to 30-Nov and 1.3 m³/s from 1-Dec to 31-May (Scruton and LeDrew, 1997). The river's habitat has been classified as predominantly riffle, run, and flat with a cobble-boulder substrate (Hiscock et al., 2002). Twillick Brook (Figure 5) was chosen to serve as an unregulated comparison to the West Salmon River. It is a tributary of the Conne River, one of the most productive salmon rivers in Newfoundland (Beacham and Dempson, 1997). Ice conditions were observed at two sites on each stream (termed upstream and downstream) and water temperatures were measured at the upstream sites only.

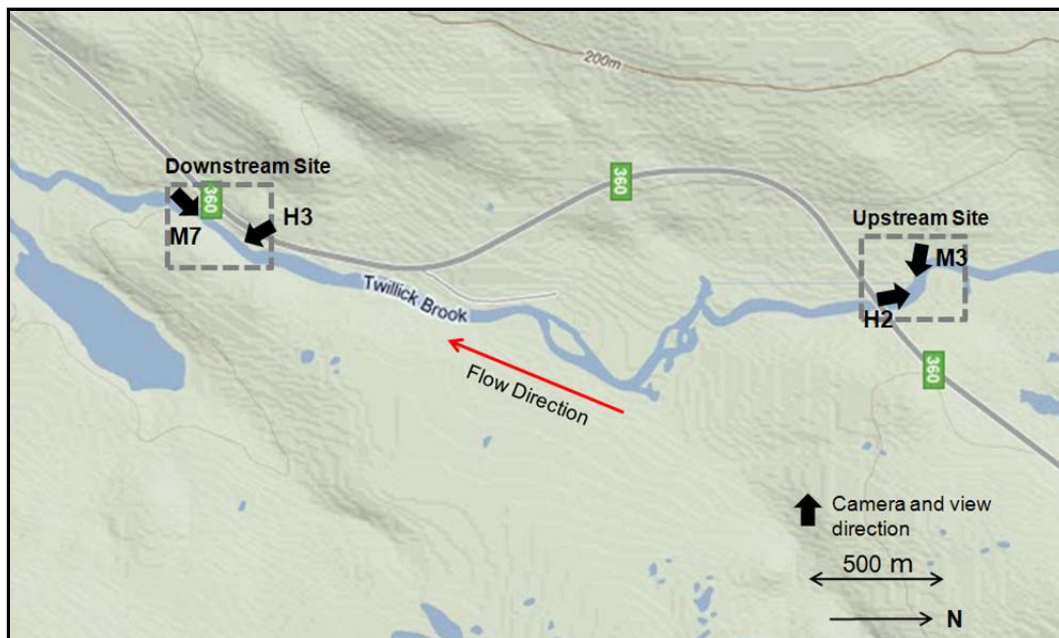
Figure 5. Location of study sites on Twillick Brook, including camera deployment locations (base image source: 2011 Google Terrain map).

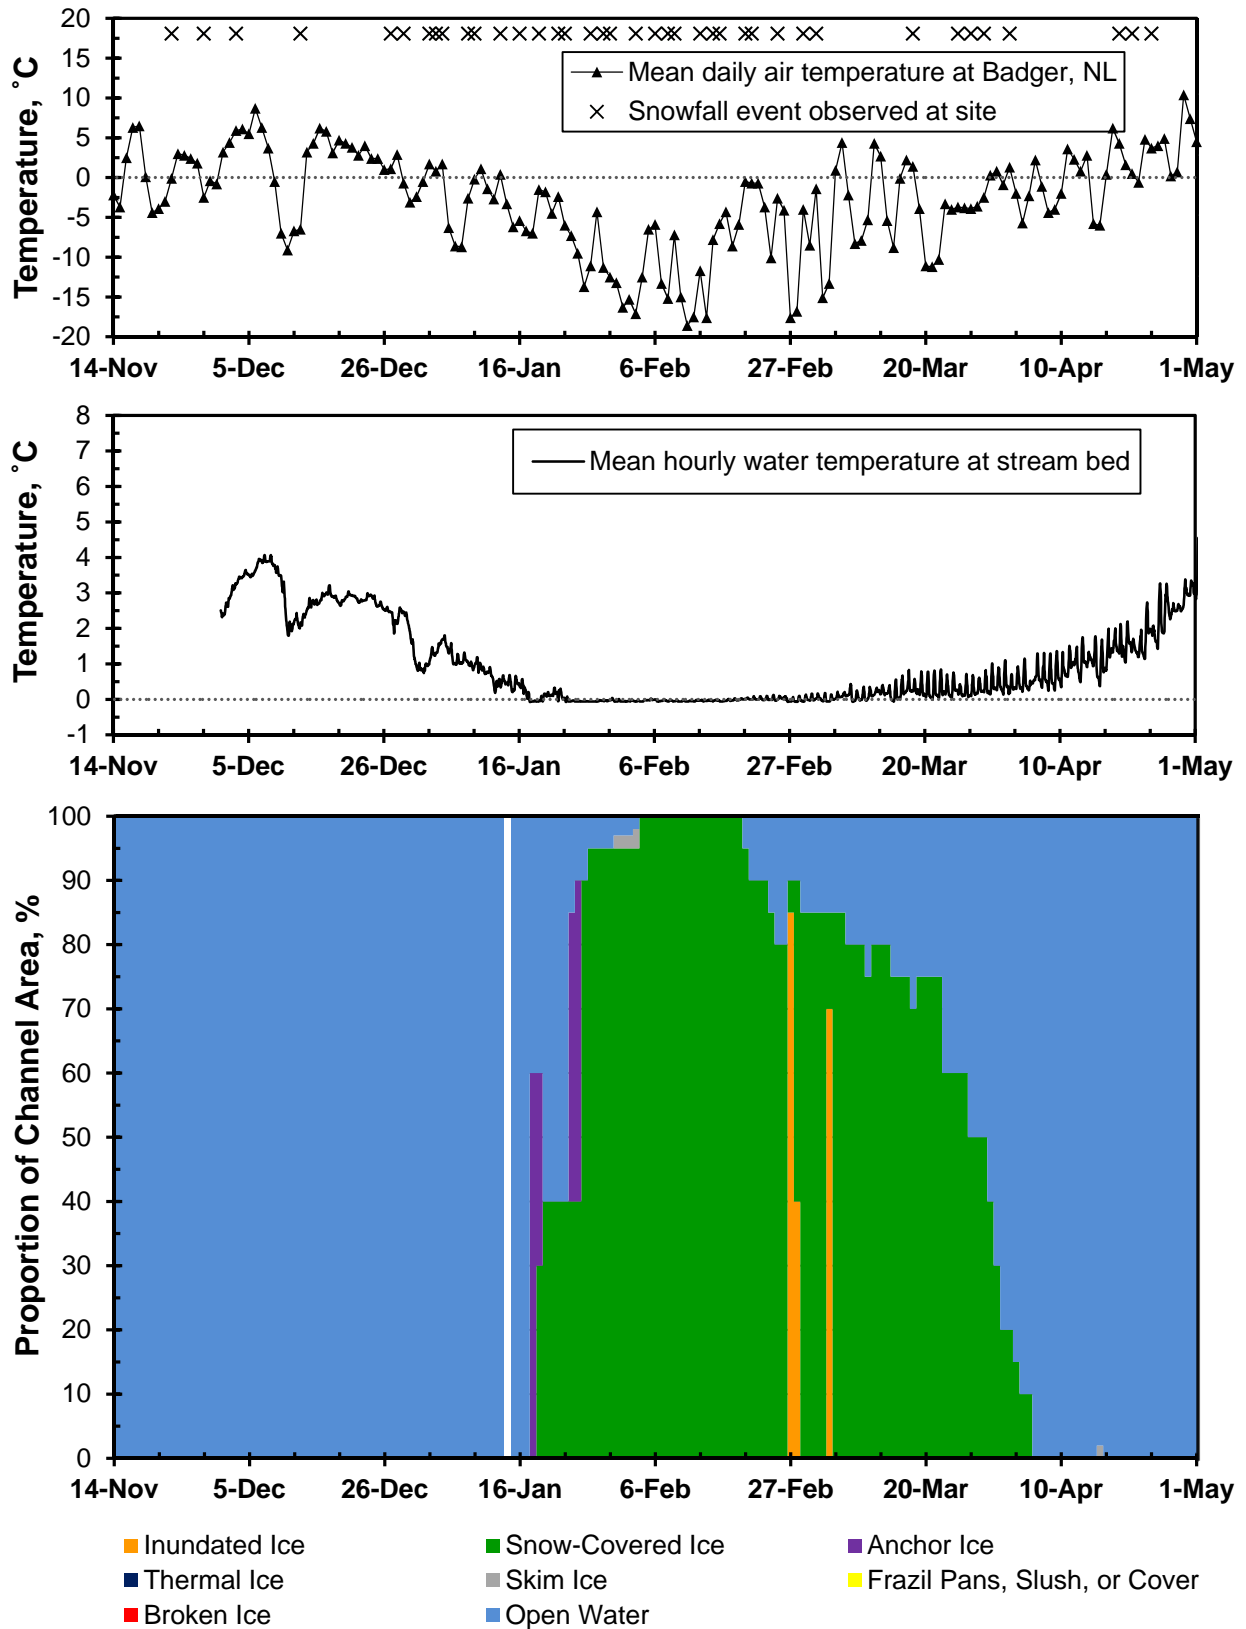
Figure 6. Ice conditions at West Salmon River (regulated) upstream site for winter 2010-2011 (cameras H1 and M1). Data gaps are denoted by white spaces.

The upstream study site on the West Salmon River was a wide (~30 to 60 m), shallow reach with many emergent boulders. As Figure 6 illustrates, freeze-up was initiated overnight on 17/18-Jan when mean daily air temperatures dropped to -7°C and water temperatures reached ~0°C. Anchor ice formed adjacent to emergent boulders and on the stream bed (Figure 7a) and was accompanied by a rise in water level. As the air temperature rose to -1.8°C on 20-Jan the water level dropped and the anchor ice diminished. Anchor ice formed again overnight on 23/24-Jan. After this date, most of the ice cover was obscured by snow. The ice cover slowly melted starting 20-Feb when the mean daily water temperature was above freezing at 0.16°C. On 27-Feb and 5-Mar the water level rose again, inundating the ice cover (Figure 7b). With the exception of skim ice forming adjacent to emergent boulders on cold nights, the site was intermittently clear of ice starting on 6-Apr and totally clear of ice from 17-Apr onwards.

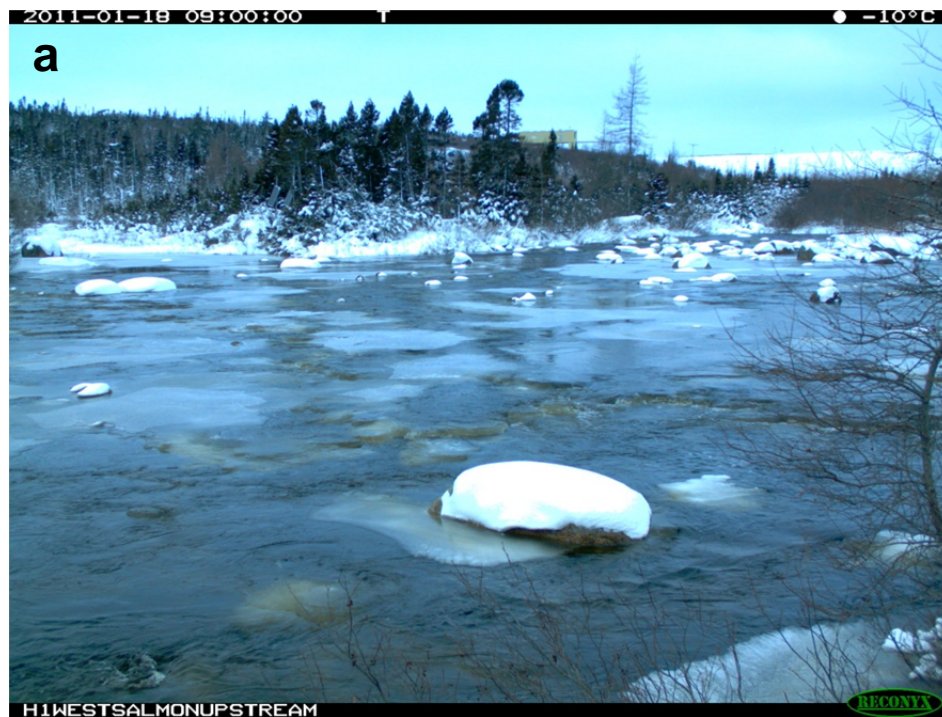
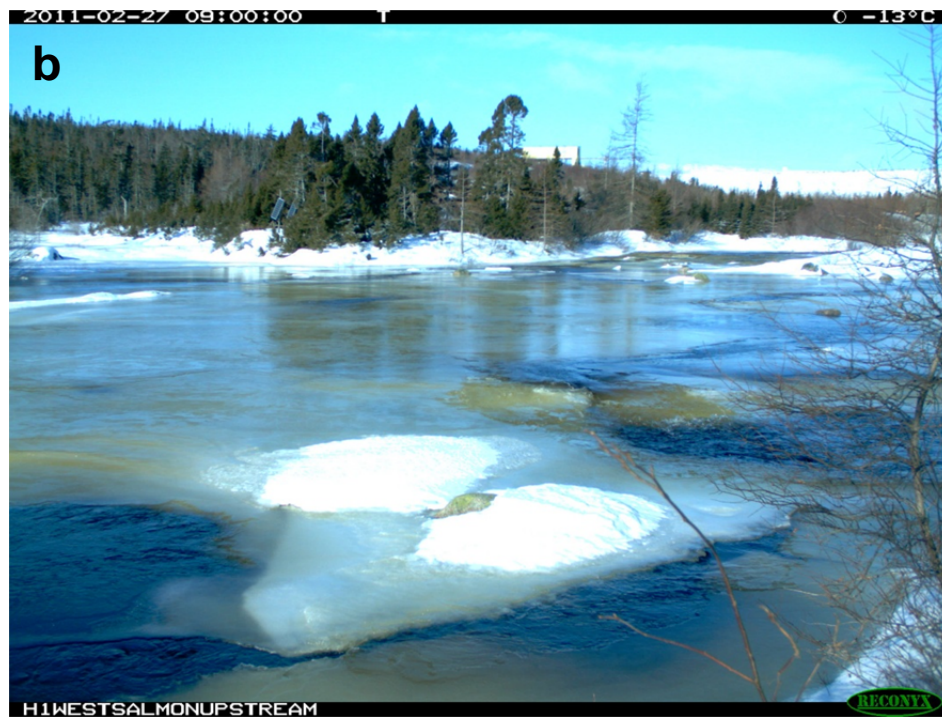
Figure 7. Ice observation photographs from the West Salmon River (regulated) upstream site taken by camera H1 showing: a) anchor ice formation on 18-Jan-11; and b) ice inundated by high water levels on 27-Feb-11.

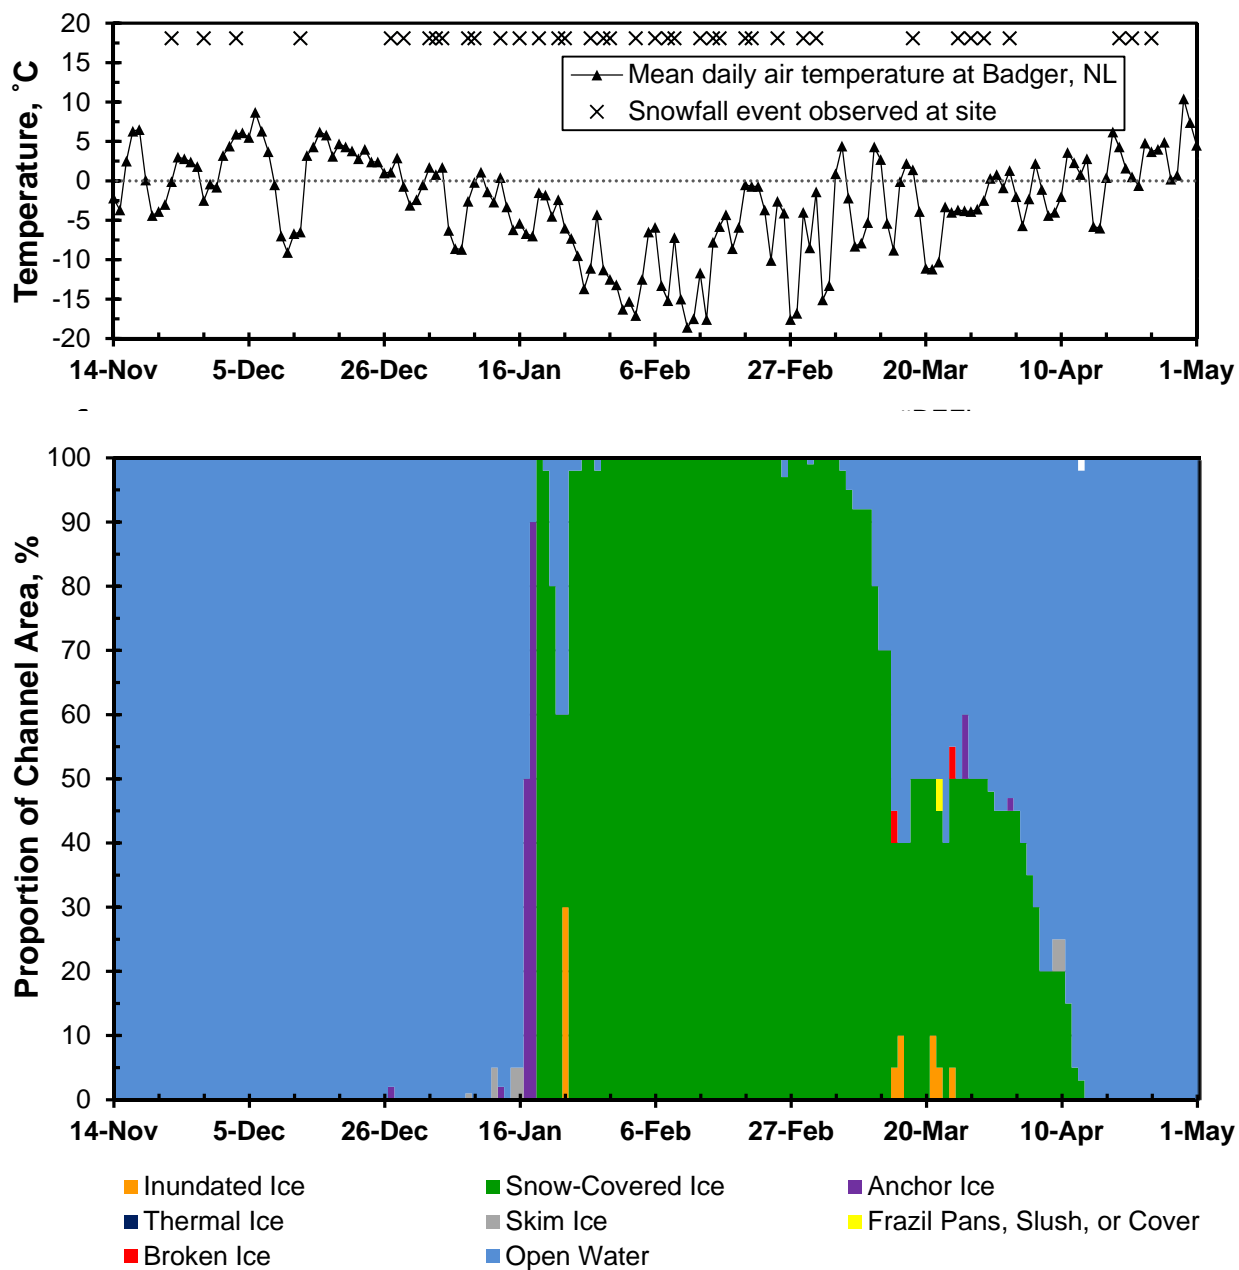
Figure 8. Ice conditions at West Salmon River (regulated) downstream site for winter 2010-2011 (cameras R3 and M2).

Grassed bars were present in the channel at the West Salmon downstream site, which was wider (~60 to 75 m), shallower, and had fewer boulders than the upstream site. Ice conditions observed at this site are summarized in Figure 8 and were similar to those observed at the upstream site. However, skim ice and small amounts of anchor ice were observed downstream before they were observed upstream. Two anchor ice formation events occurred on 17/18-Jan and 23/24-Jan (Figure 9a), the same dates as those observed at the upstream site. After this time, the stream remained almost entirely ice-covered until ice melt began in early March. Broken pieces of ice were observed at the site on 15-Mar and 24-Mar (Figure 9b). These pieces moved through the site over the course of the day. The site was permanently ice free on 14-Apr.

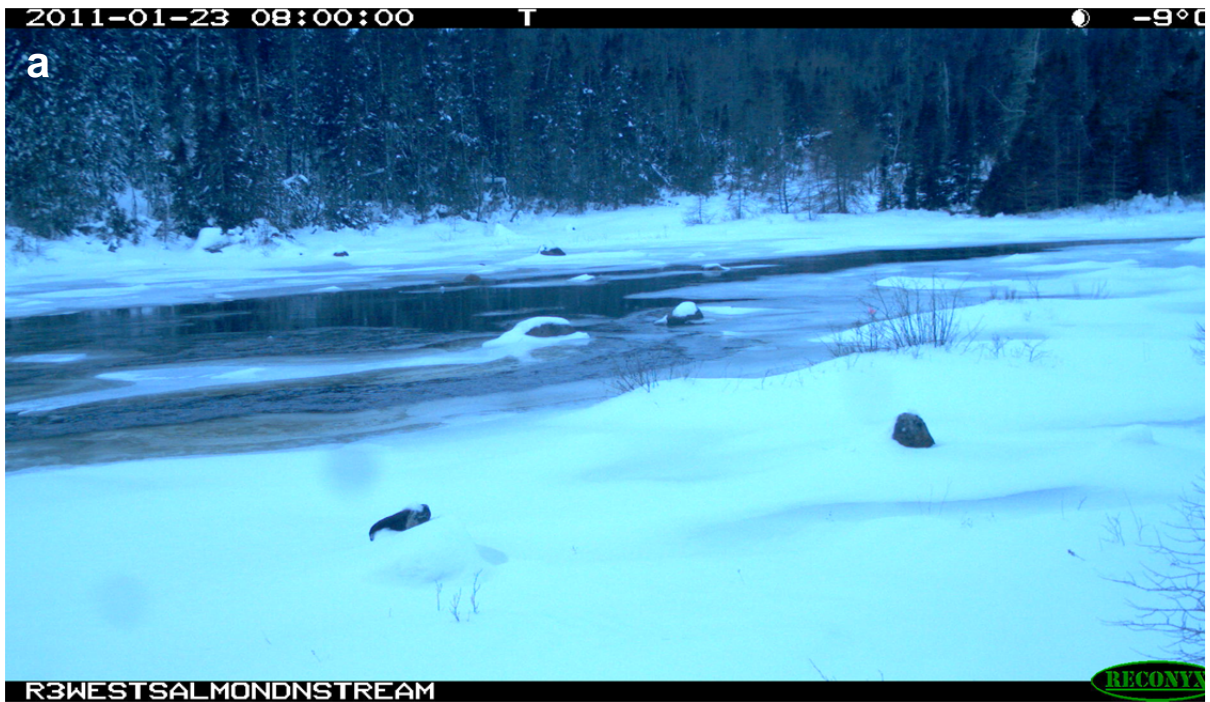
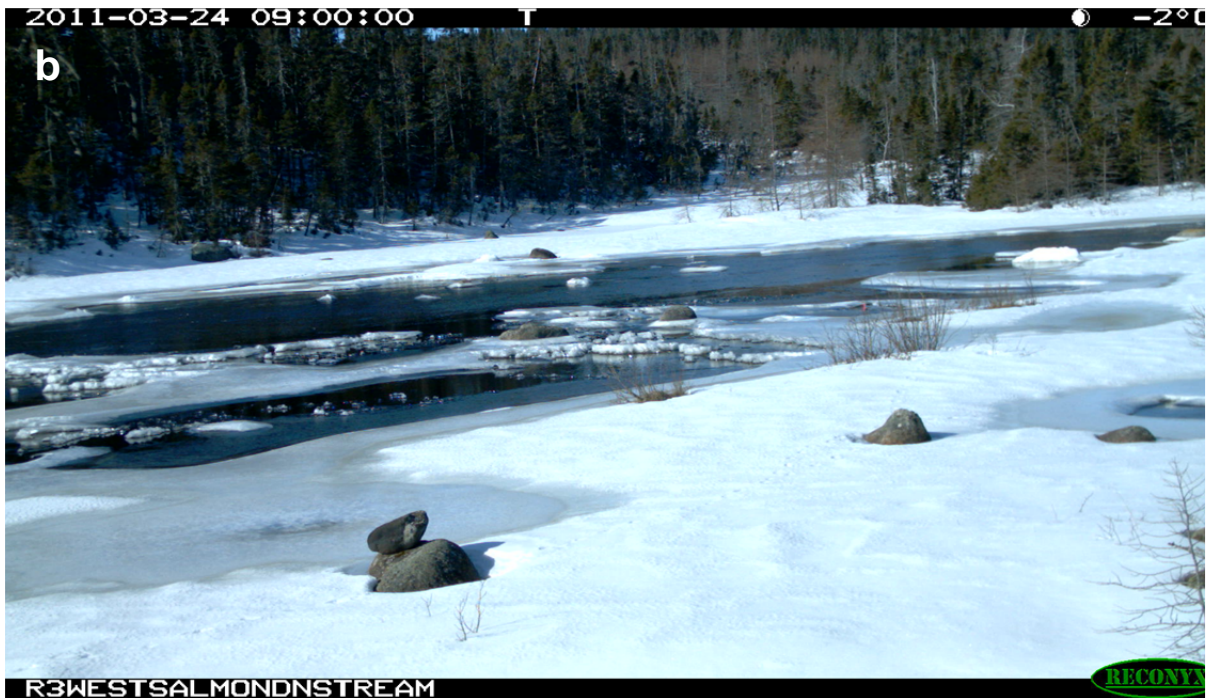
Figure 9. Ice observation photographs from the West Salmon River (regulated) downstream site taken by camera R3 showing: a) anchor ice on 23-Jan-11; and b) broken ice in the channel on 24-Mar-11.

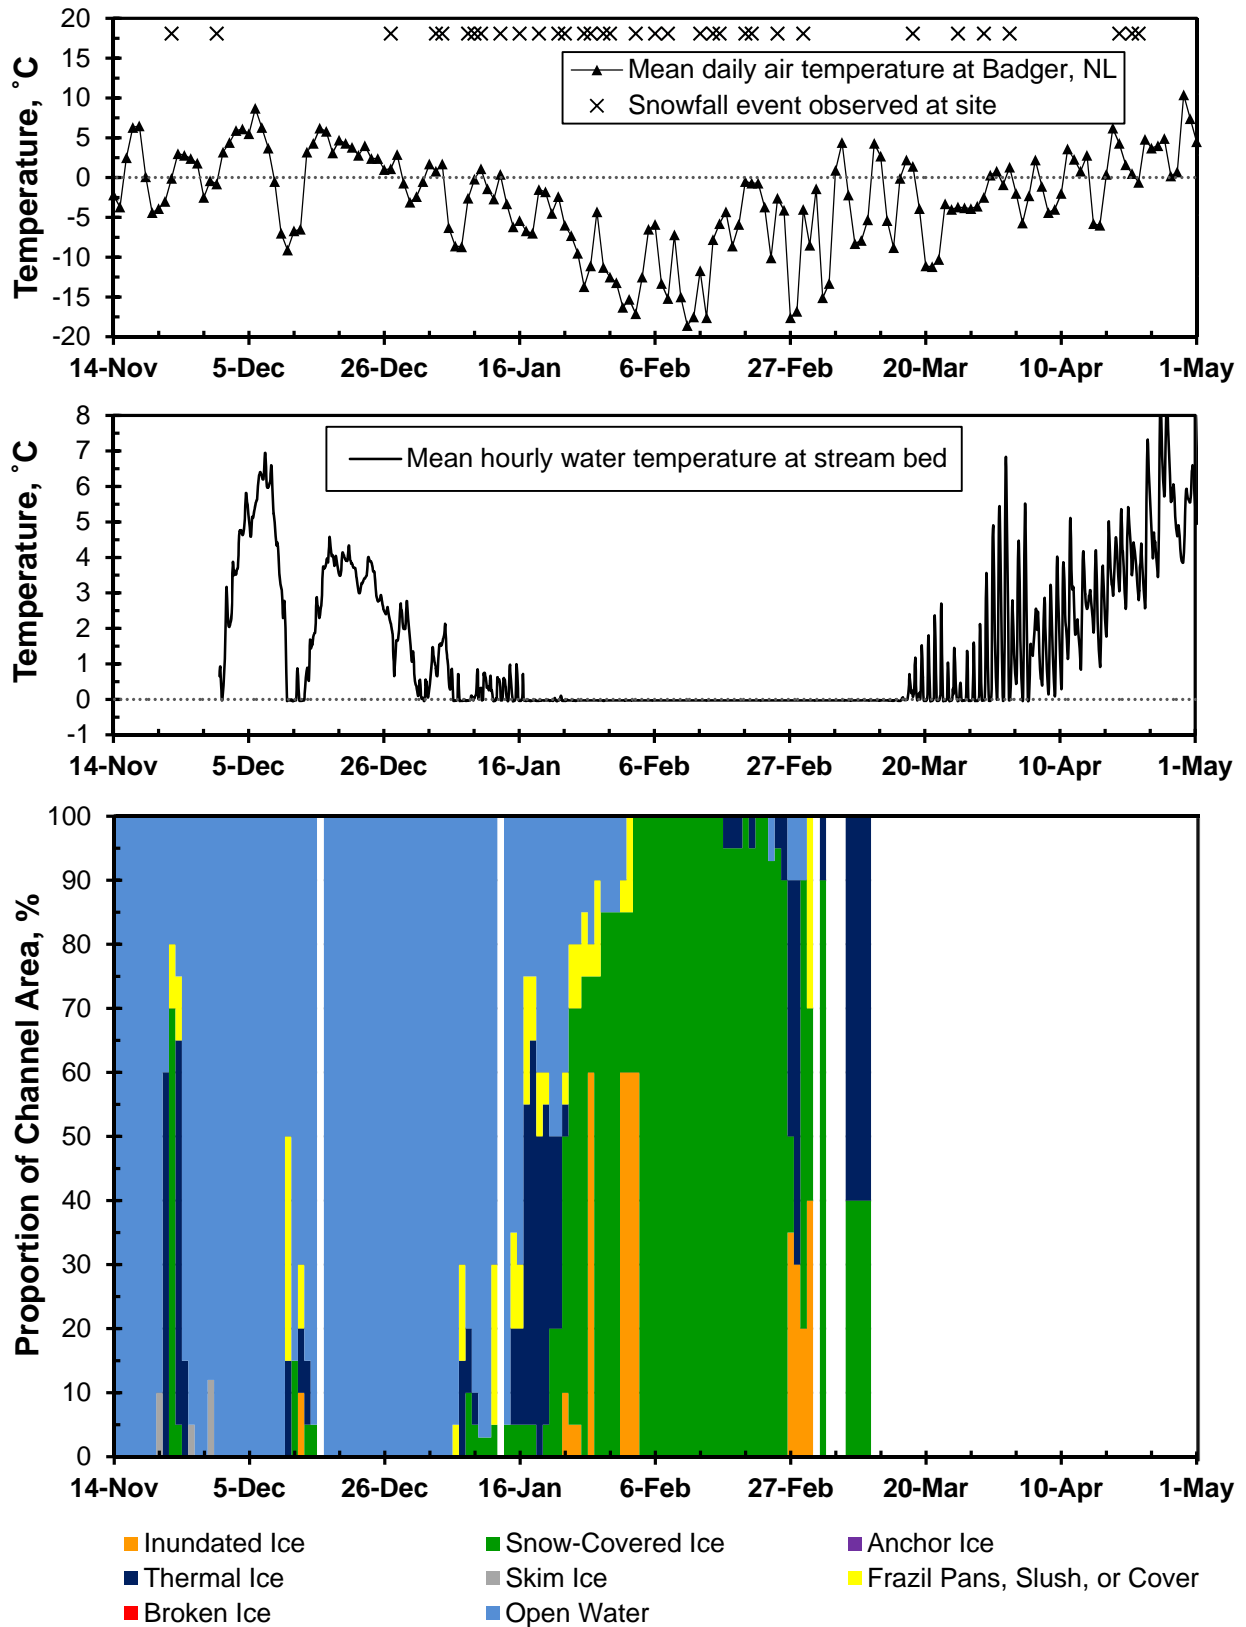
Figure 10. Ice conditions at Twillick Brook (unregulated) upstream site for winter 2010-2011 (cameras H2 and M3). Data gaps are denoted by white spaces.

The upstream study site on Twillick Brook was a 40 to 50 m wide, wadeable stream. The observed reach consisted of a pool and a riffle, with a small, frequently submerged grassed bar adjacent to the riffle. One camera at this site was the one that was improperly programmed (and thus did not take any ice photos), while the other was one of the Moultrie cameras that stopped before the memory card was full (and thus took photos only until 12-Mar), prior to breakup. Ice conditions observed at this site are summarized in Figure 10. Freeze-up processes were dominated by the growth of thermal/border ice from the stream margins and from the edges of the bar. This occurred first on 21-Nov when mean daily air temperatures dropped to -3.9°C , before melting and re-forming on 11-Dec (minimum daily air temperature: -9.1°C) and then re-melted. During each of these ice-forming events the measured water temperature dropped to $\sim 0^{\circ}\text{C}$. Permanent ice first formed when both border ice growth and frazil slush were observed on 6-Jan. Ice first covered the entire reach on 2-Feb when a freeze-up front passed by the observation camera and mean daily air temperatures reached -15.3°C (Figure 11a). The water level rose in the stream, partially inundating the ice cover on 23 to 27-Jan, 1 to 3-Feb, and 27-Feb to 2-Mar (Figure 11b). Water temperatures remained at $\sim 0^{\circ}\text{C}$ from 17-Jan to 16-Mar.

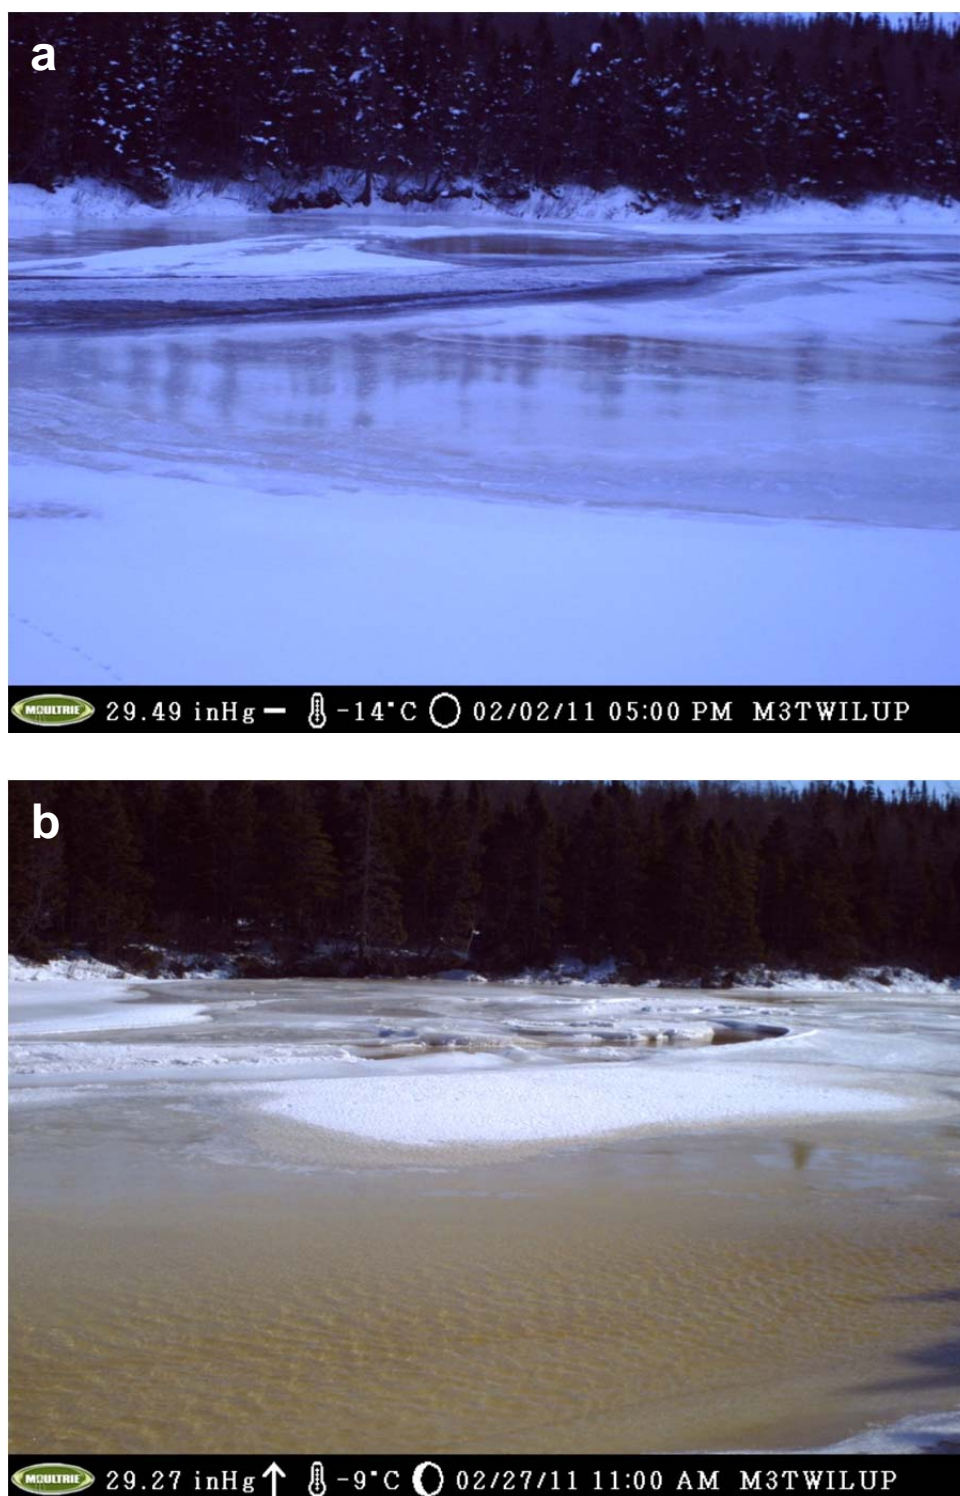
Figure 11. Ice observation photographs from Twillick Brook (unregulated) upstream site taken by camera M3 showing: a) frazil ice filling in an ice cover on 2-Feb-11 and; b) ice inundated by high water levels on 27-Feb-11.

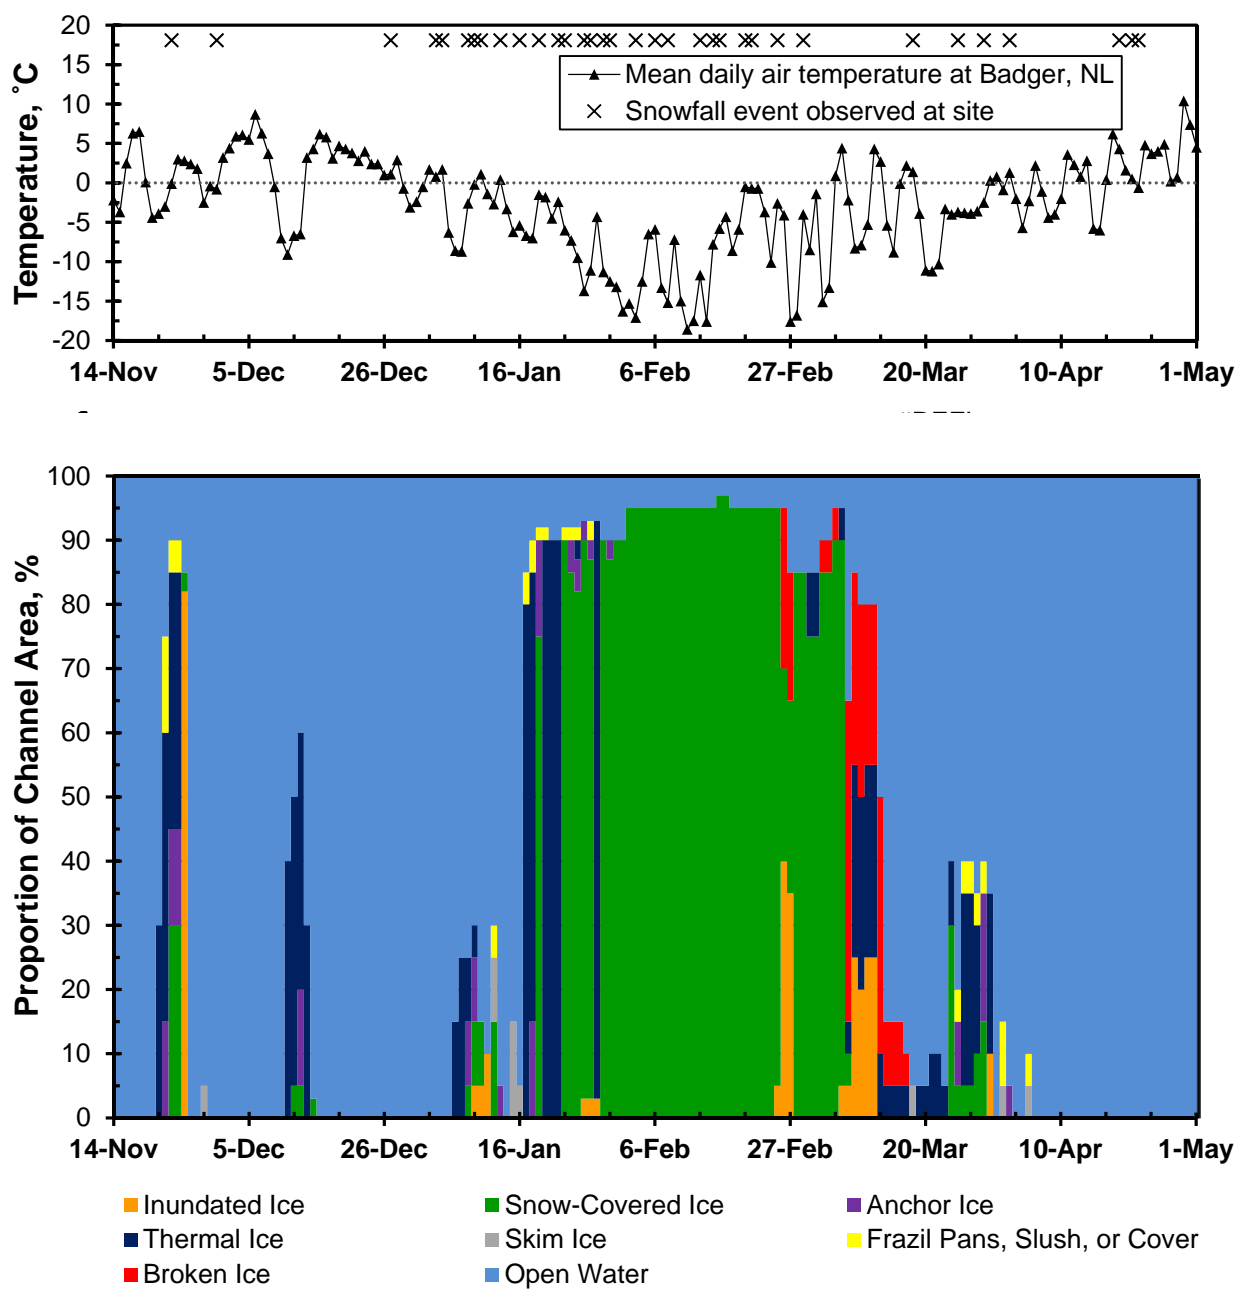
Figure 12. Ice conditions at Twillick Brook (unregulated) downstream site for winter 2010-2011 (cameras H3 and M7).

The downstream study site on Twillick Brook was a 30 to 40 m wide, wadeable stream. The observed reach consisted of a pool and a riffle, with a few emergent boulders on the riffle and a very large bedrock remnant near the left bank. The bedrock banks at this site were high and steep. As Figure 12 illustrates, freeze-up processes were similar to those observed at the upstream site; however, anchor ice was observed in the fast portion of the riffle, while no anchor ice was observed at the upstream site. Similar to the upstream site, freeze-up processes began with thermal ice growth and frazil activity on two separate occasions: 21-Nov and 11-Dec (Figure 13a) before the ice retreated and completely melted. Permanent ice growth also began on 6-Jan and was dominated by thermal ice growth, some frazil activity and anchor ice on the riffle. This reach did not entirely freeze over, as an open lead was present all winter. Breakup began 25-Feb when the rapids upstream of the site appeared to open up and mean daily air temperatures reached -2.6°C . Broken ice moved into the reach and over the top of the intact ice at the study site. The permanent ice at the study reach began to breakup 8-Mar, while mean daily air temperature first reached above $\sim 0^{\circ}\text{C}$ the day before on 7-Mar. This culminated in a small ice jam (Figure 13b) which was most pronounced on 13-Mar and then slowly cleared downstream over the next several days. Following the clearing of the winter ice from the reach, border ice formed at the channel margins and floating frazil slush formed a floating cover over the small open central portion. Anchor ice was again observed at the riffle at this time. The channel was first completely ice free on 31-Mar and permanently ice free 6-Apr.

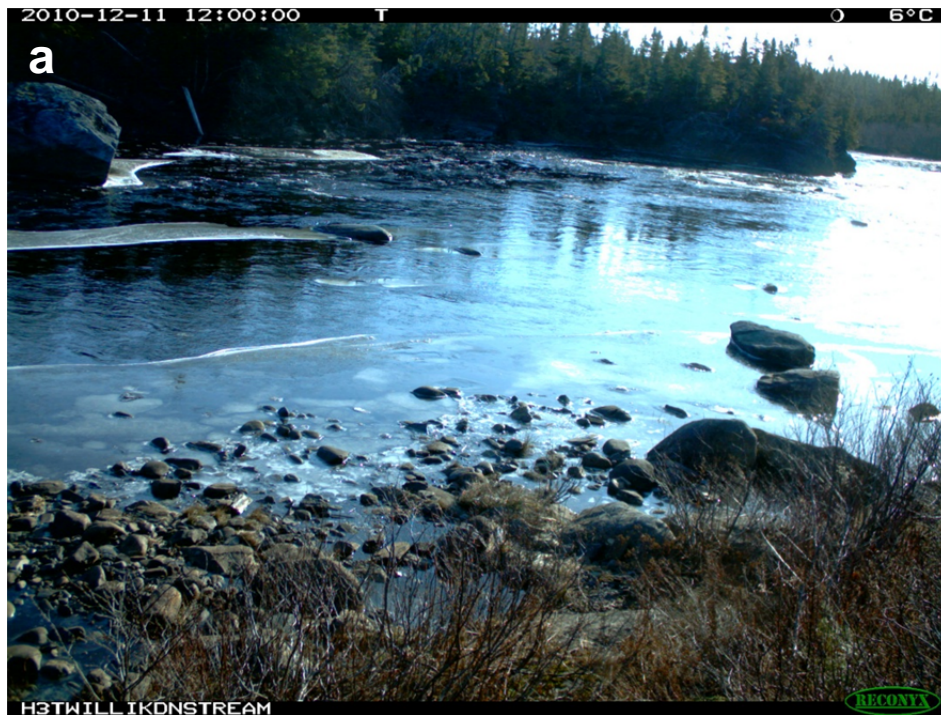
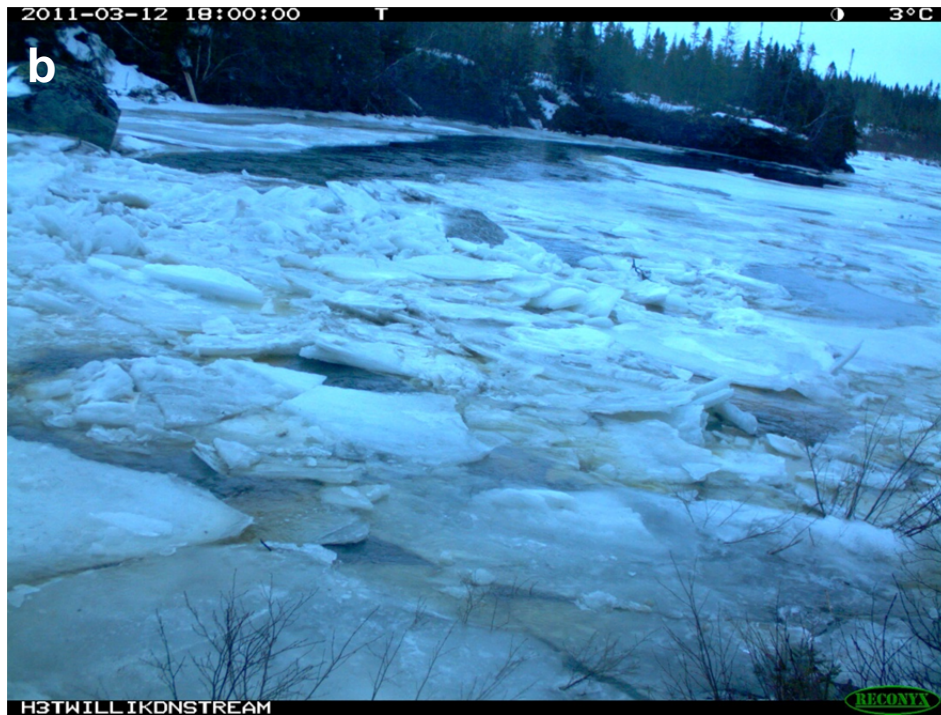
Figure 13. Ice observation photographs from Twillick Brook (unregulated) downstream site taken by camera H3 showing: a) partial ice cover on 11-Dec-10; and b) small ice jam on 12-Mar-11.

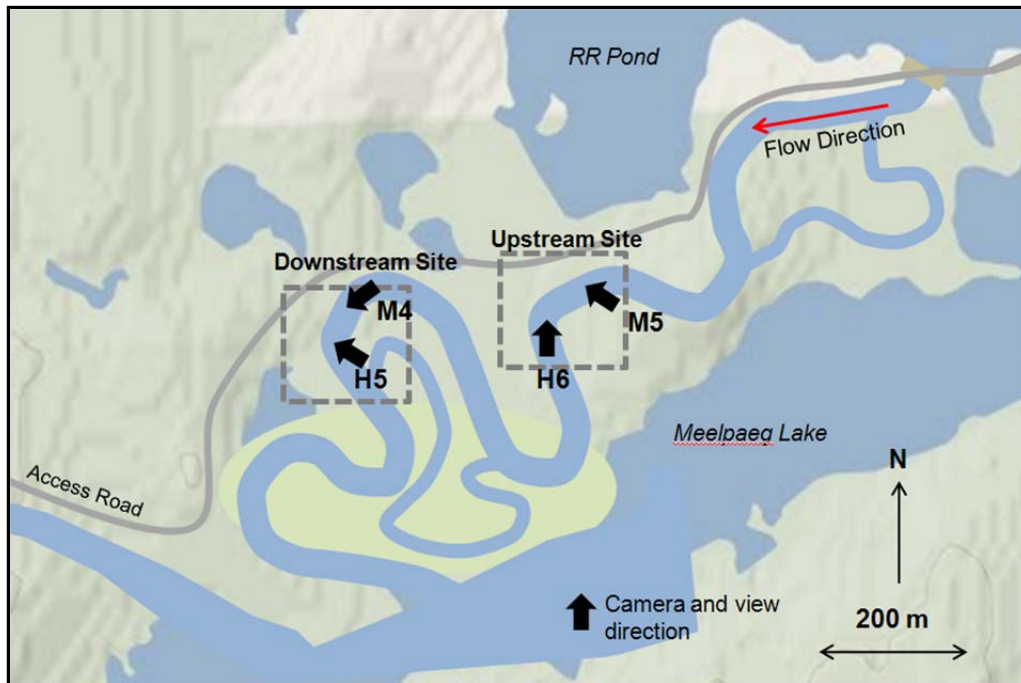
Figure 14. Location of the study sites on Compensation Creek, including camera deployment locations (base image source: 2011 Google Terrain map).

Two streams were studied in the Granite Canal area. Compensation Creek is a man-made, regulated stream designed as habitat for both landlocked Atlantic salmon and brook trout (Figure 14). Flow into the creek is regulated by a control gate, which releases water stored in RR Pond to an arm of Meelpaeg Lake (Gabriel et al., 2009). The stream consists of a 1600 m long, low-gradient channel with two side channels and is dominated by riffle-pool morphology (Enders et al., 2007). An unnamed creek (Figure 15), located approximately 11 km north of the Granite Canal camp, was chosen to serve as a natural flow comparison stream to Compensation Creek

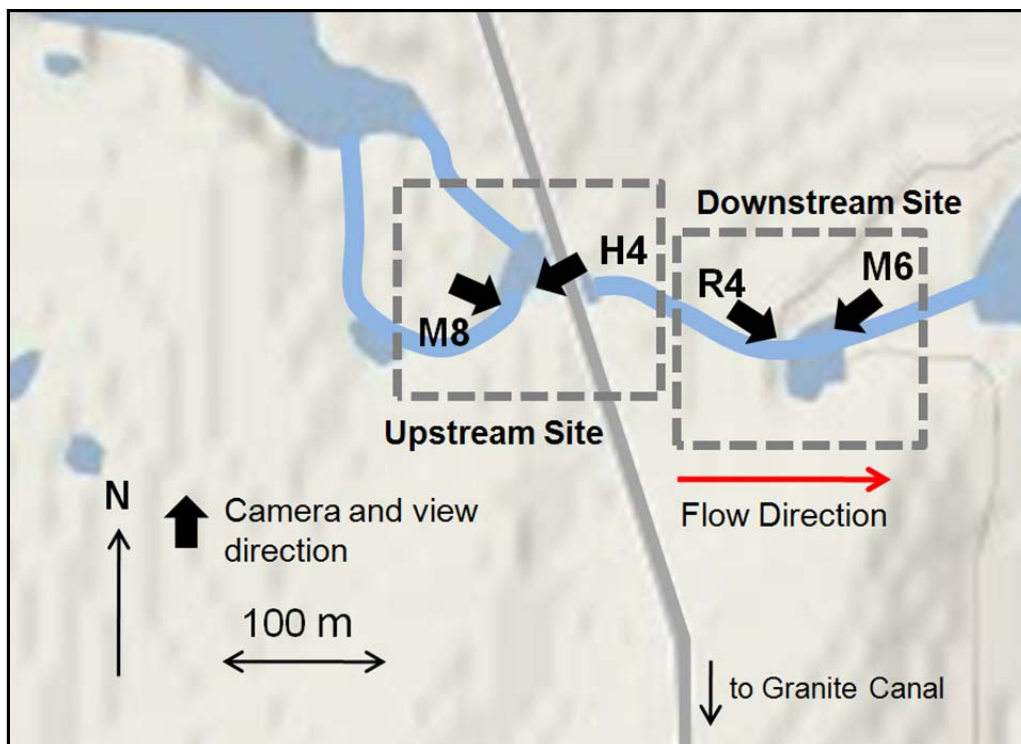
Figure 15. Location of the study sites on the unnamed creek, including camera deployment locations (base image source: 2011 Google Terrain map).

(Figure 15). This creek drains an area west of the Granite Canal Road through a series of ponds before running under a Bailey bridge. The stream then flows for another 500 m before emptying into an unnamed pond east of the road. Two sites were studied on each stream (herein termed upstream and downstream).

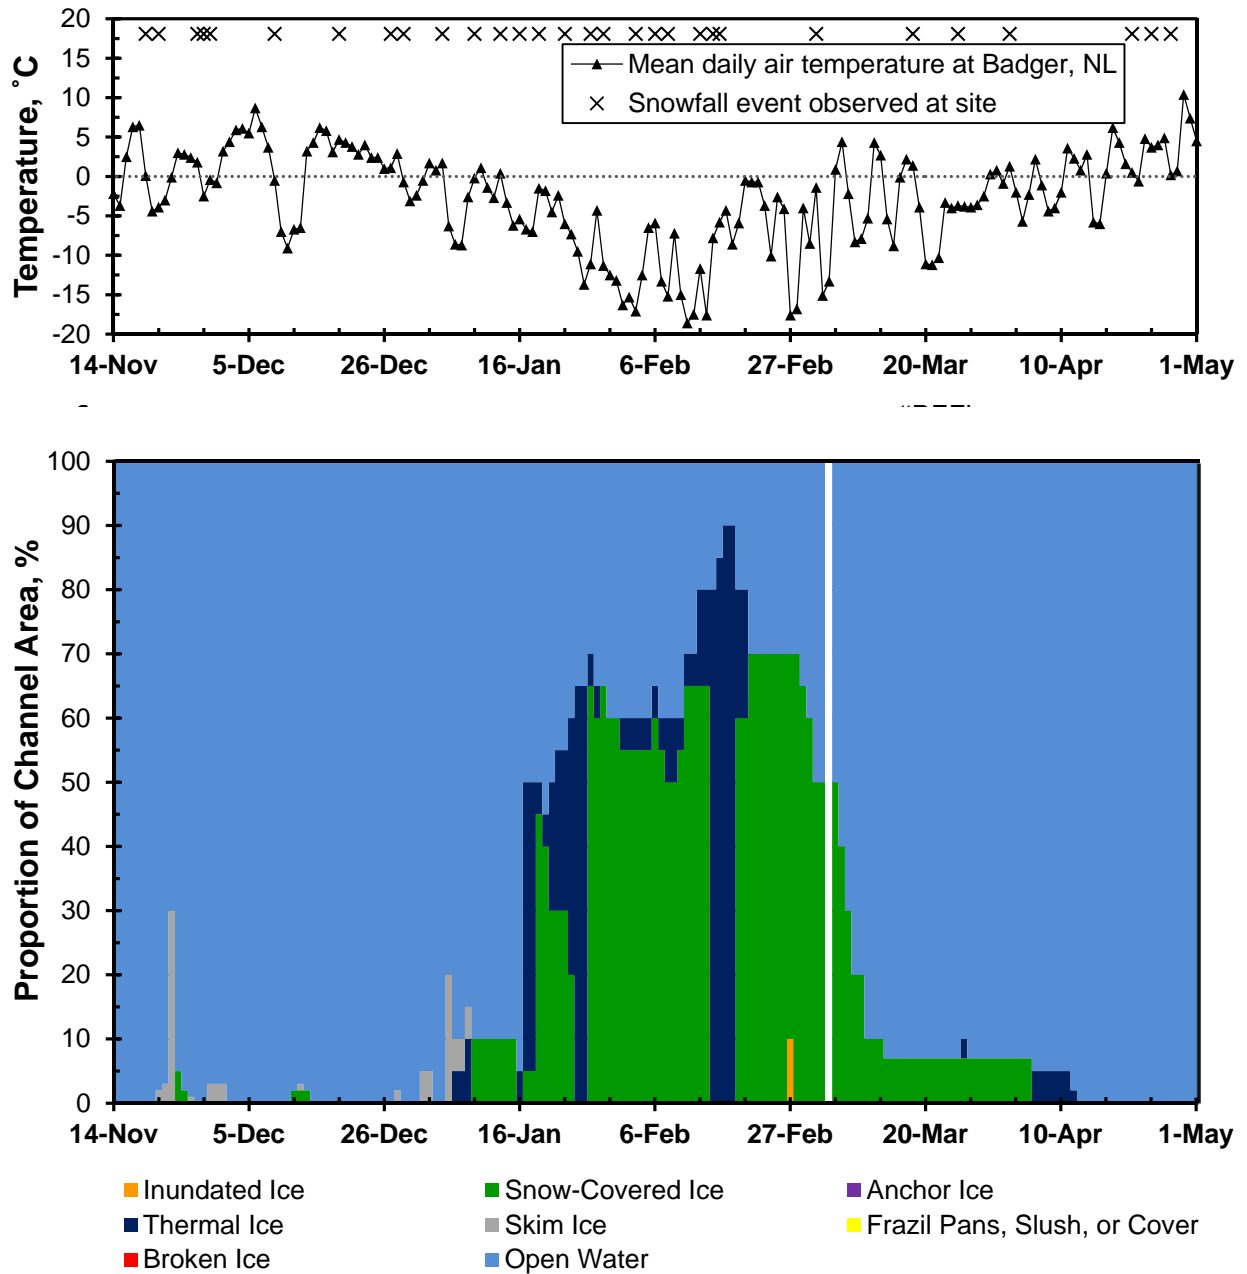
Figure 16. Ice conditions at Compensation Creek (regulated) upstream site for winter 2010-2011 (cameras H6 and M5). Data gaps are denoted by white spaces.

The upstream study reach on Compensation Creek was a ~15 m wide pool section at the apex of a bend. As Figure 16 illustrates, the freeze-up processes at this site were dominated by thermal border ice growth. The first ice growth occurred as skim ice at the channel margins on 21-Nov when mean daily air temperatures dropped to -3.1°C . This skim ice formed, melted and reformed repeatedly until 5-Jan, when the first permanent ice formed. This ice gradually advanced and retreated over the course of the season, with a maximum of 90% border ice coverage (Figure 17a) on 17/18-Feb when mean daily air temperatures dropped to -8.6°C . The ice slowly melted until the first ice-free day 13-Apr. There were two events on the mornings of 1-Jan and 2-Jan where the water level dropped so significantly that much of the channel bed was exposed (Figure 17b).
