Freeze-up, breakup, and winter ice observations on four small regulated and unregulated streams in Newfoundland, Canada

Although winter ice processes are well documented in large, low-gradient rivers, only a few studies on smaller, steeper streams have been published, and none compare regulated environments to unregulated ones. This paper documents the ice conditions observed on two regulated and two unregulated, wadeable streams in south-central Newfoundland from October 2010 to May 2011. Ice conditions were observed using 16 remote camera stations at eight salmonid spawning sites along West Salmon River, Twillick Brook, Compensation Creek, and another unnamed creek. The West Salmon River and Compensation Creek are both regulated streams, while Twillick Brook and the unnamed creek were chosen as potential (unregulated) reference sites.

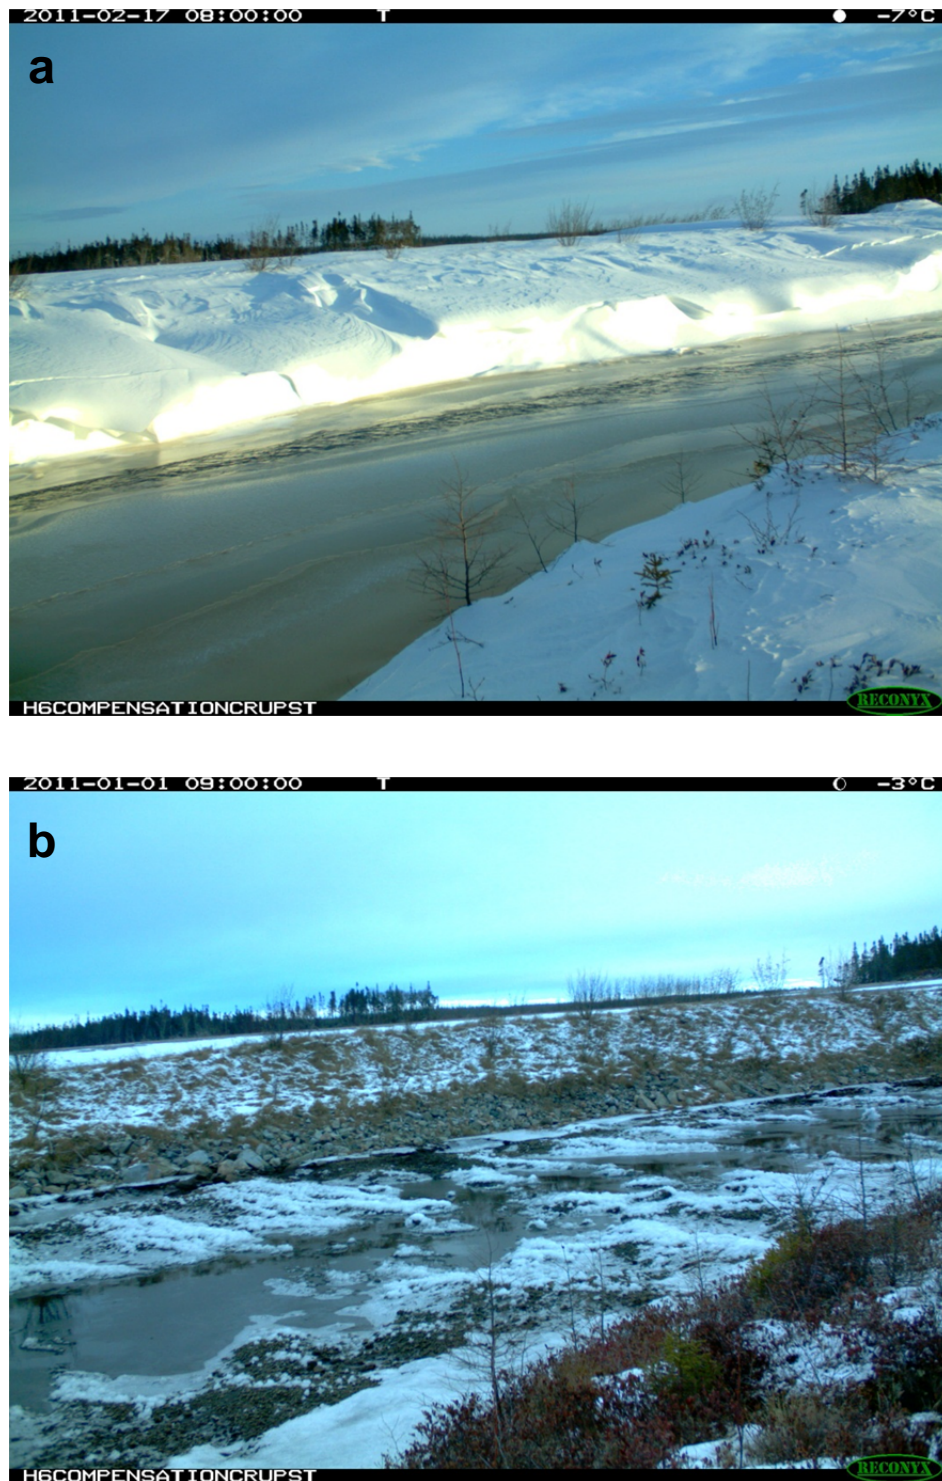
Figure 17. Ice observation photographs from Compensation Creek (regulated) upstream site taken by camera H6 showing: a) ice cover on 17-Feb-11 and; b) low water condition on 1-Jan-11.

The upstream study reach on Compensation Creek was a ~15 m wide pool section at the apex of a bend. As Figure 16 illustrates, the freeze-up processes at this site were dominated by thermal border ice growth. The first ice growth occurred as skim ice at the channel margins on 21-Nov when mean daily air temperatures dropped to -3.1°C . This skim ice formed, melted and reformed repeatedly until 5-Jan, when the first permanent ice formed. This ice gradually advanced and retreated over the course of the season, with a maximum of 90% border ice coverage (Figure 17a) on 17/18-Feb when mean daily air temperatures dropped to -8.6°C . The ice slowly melted until the first ice-free day 13-Apr. There were two events on the mornings of 1-Jan and 2-Jan where the water level dropped so significantly that much of the channel bed was exposed (Figure 17b).

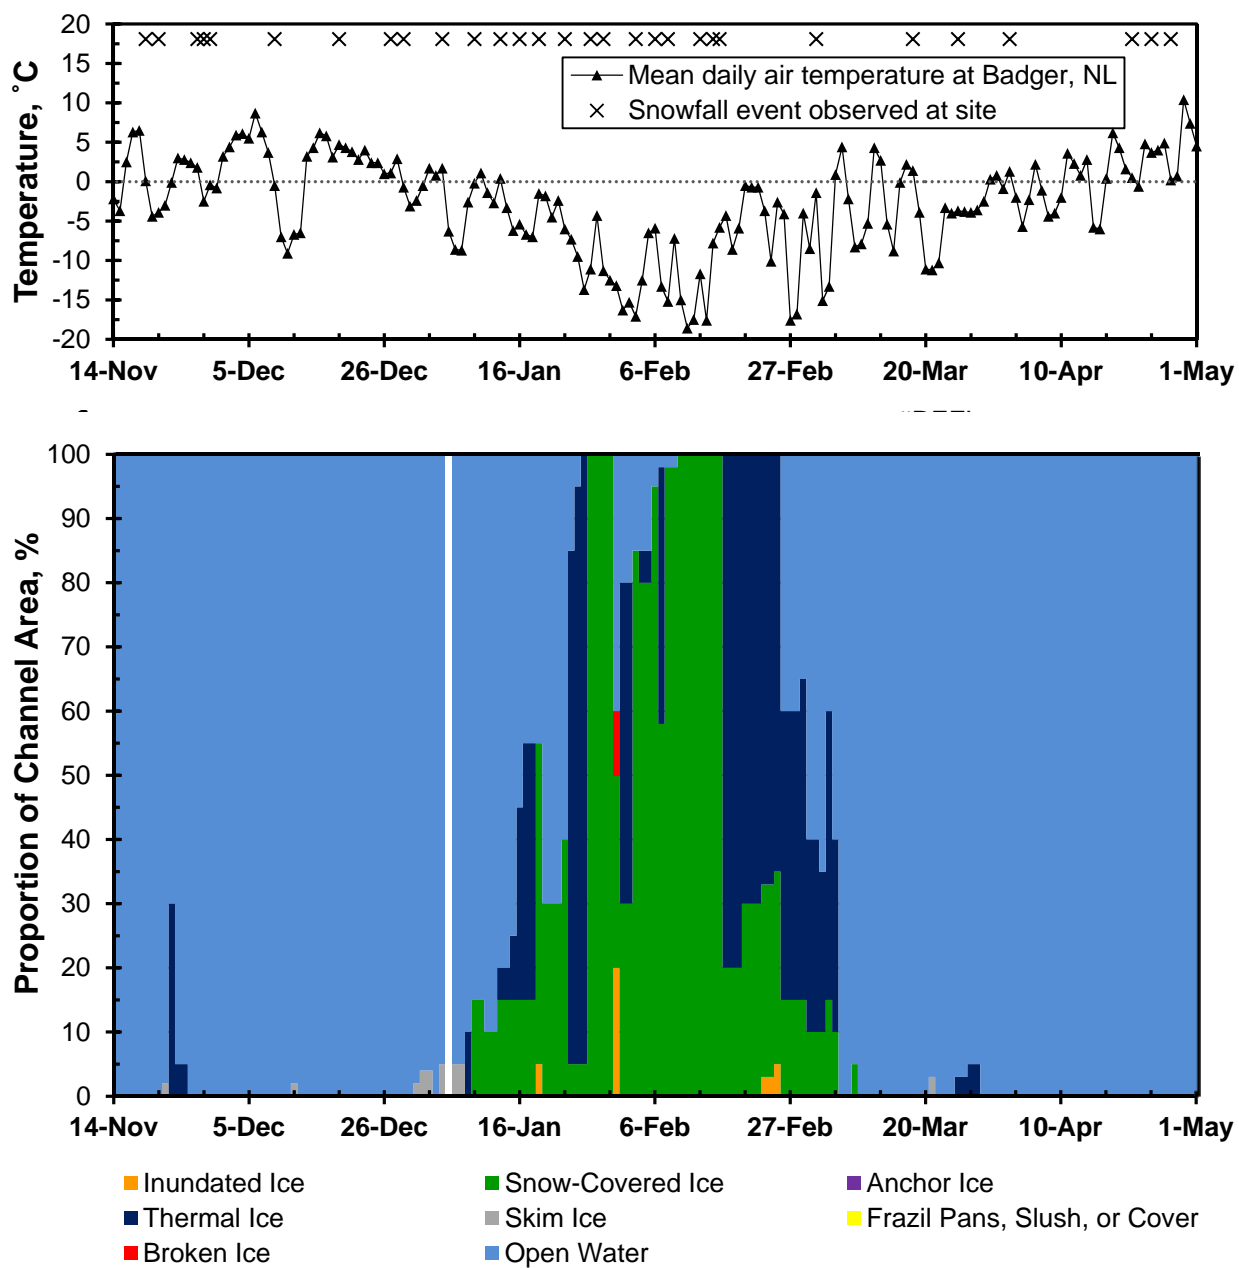
Figure 18. Ice conditions at Compensation Creek (regulated) downstream site for winter 2010-2011 (cameras H5 and M4). Data gaps are denoted by white spaces.

The downstream study reach on Compensation Creek (regulated) was a ~15 m wide reach at the downstream end of a bend with emergent boulders. As Figure 18 illustrates, the freeze-up processes at this site were similar to those at the upstream reach in that they were dominated by thermal ice growth. However, unlike the upstream reach, a complete ice cover formed here. The ice cover first began to form at the channel margins as well as at the boundaries of the emergent boulders 22-Nov when mean daily temperatures dropped to -3°C . This ice cover melted before reforming briefly on 12-Dec when mean daily temperatures dropped to -6.7°C . There were two events on the mornings of 1-Jan and 2-Jan where the water level dropped so significantly that much of the channel bed was exposed. The first permanent ice began to form 4-Jan, though no data exist for 5-Jan because of fog or frost on the camera lenses. This ice cover gradually advanced from the stream borders and the emergent boulders (Figure 19a). Broken ice was observed on 31-Jan when the water level dropped, exposing ice shelves attached to the boulders (e.g. Figure 19b), which cracked and collapsed. The thermal ice gradually retreated, with the first ice free day occurring 7-Mar and the channel permanently open from 29-Mar onward.

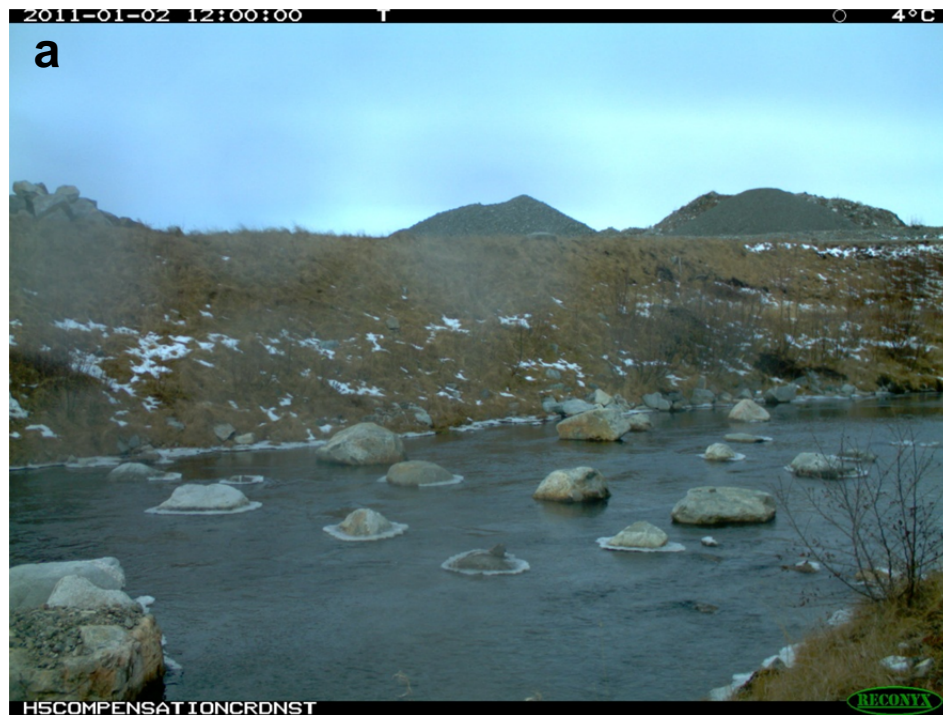
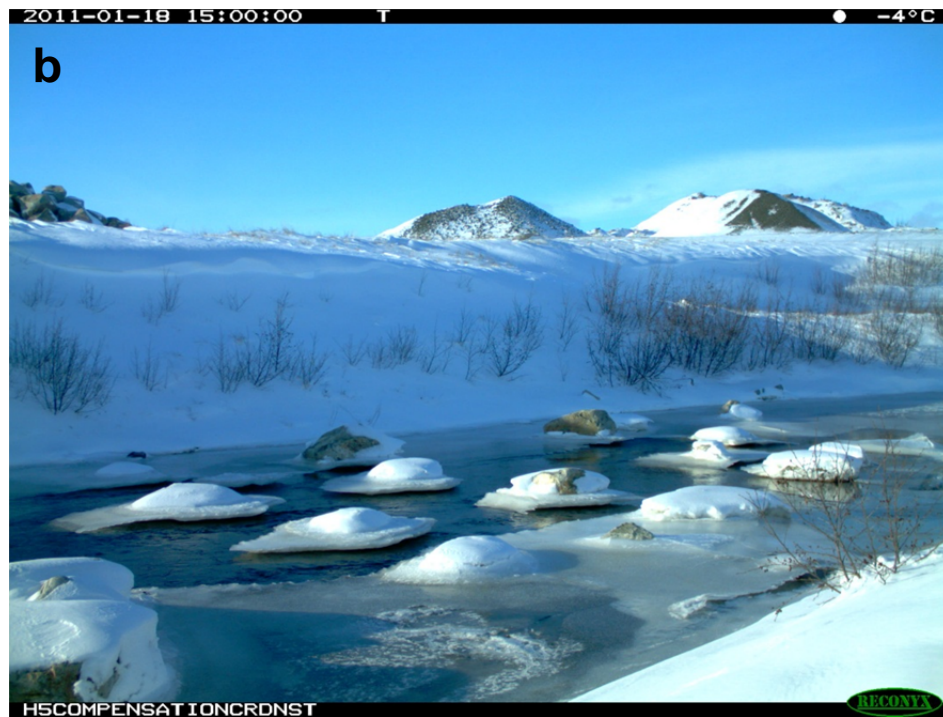
Figure 19. Ice observation photographs from Compensation Creek (regulated) downstream site taken by camera H5 showing: a) ice cover advancing from boulders and stream margins on 2-Jan-11; and b) ice shelves on 18-Jan-11.

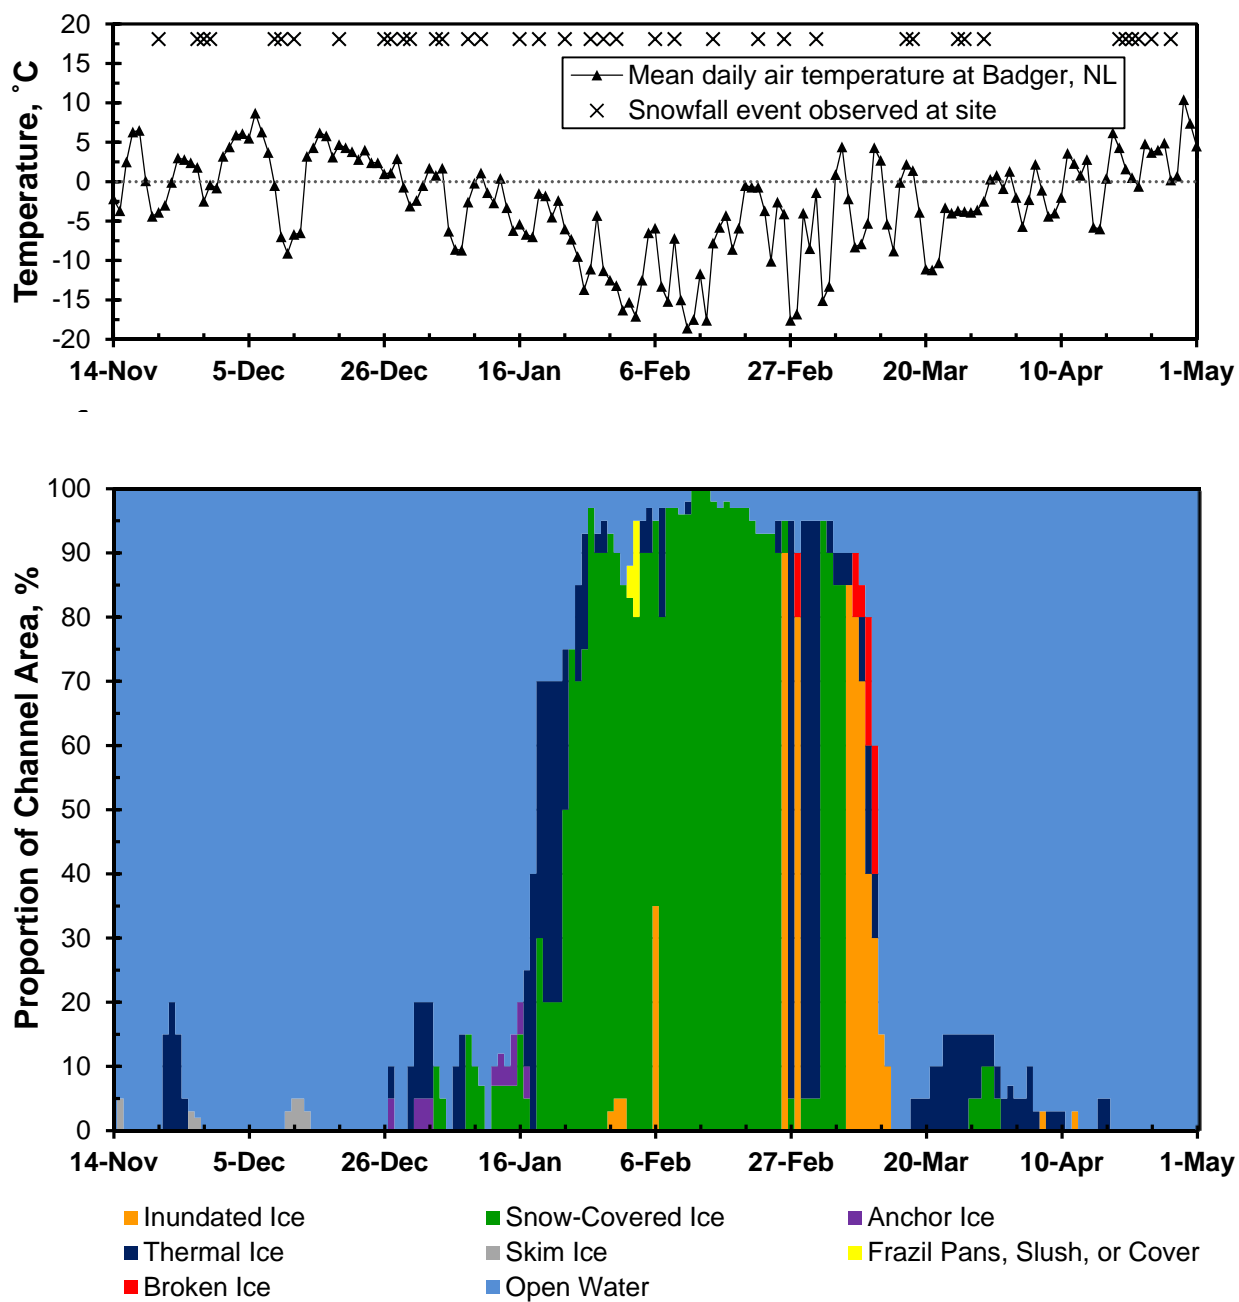
Figure 20. Ice conditions at No Name Creek (unregulated) upstream site for winter 2010-2011 (cameras H4 and M8).

The upstream study reach on the unregulated unnamed creek was an ~8 m wide wadeable reach with step-pool morphology. Two pools and two steps were included in the observed area. As Figure 20 illustrates, freeze-up processes at this site were dominated by thermal ice growth on the pools and anchor ice growth on the exposed boulders at the steps. The first ice growth observed was on 15-Nov when skim ice formed at the margins of the pools. Thermal ice formed and melted periodically starting 22-Nov, 11-Dec, 27-Dec, 30-Dec, and 6-Jan, which are all periods when the mean daily temperature dropped to below 0°C . The first permanent ice 12-Jan (Figure 21a). In all instances, ice formed as thermal ice on the surface of the pools and anchor ice adjacent to the boulders in the stream. Floating frazil slush ice was observed 2-Feb and 3-Feb on the surface of the pools, stranded behind the frozen boulder steps (Figure 21b). The channel was 100% covered by ice for only 3 days from 12-Feb to 14-Feb, while much of the time, an open lead existed at the base of one of the steps. Breakup began when rising water levels inundated the ice cover on 26-Feb and 28-Feb, followed by ice cracking on 28-Feb. The reach then re-froze before being inundated again by rising water levels 8-Mar to 14-Mar, when the ice broke up and was cleared from the reach. Thermal ice began to reform 18-Mar when the

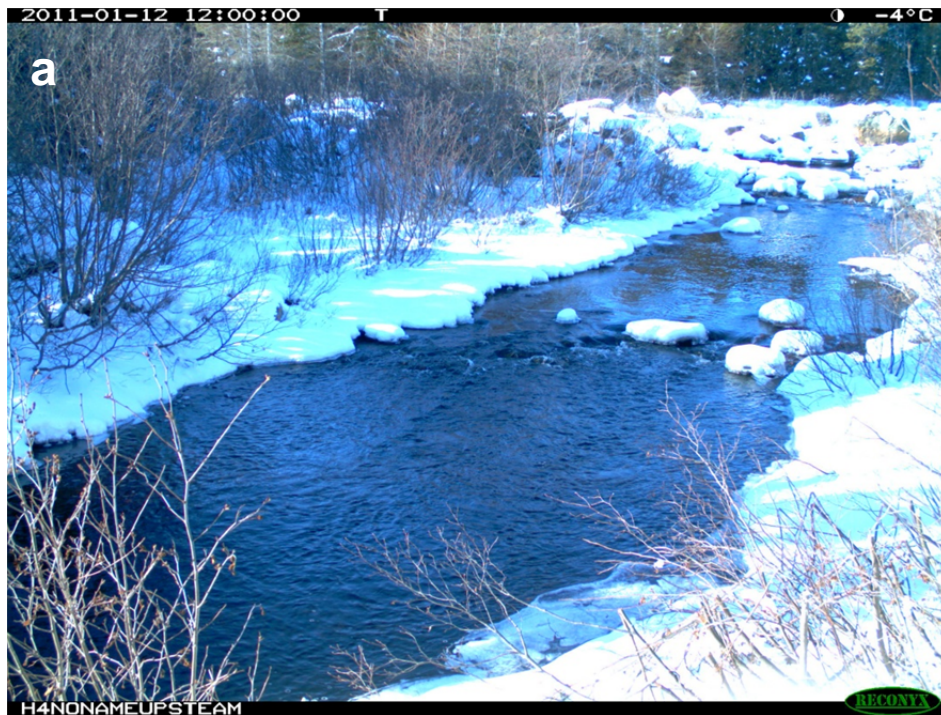
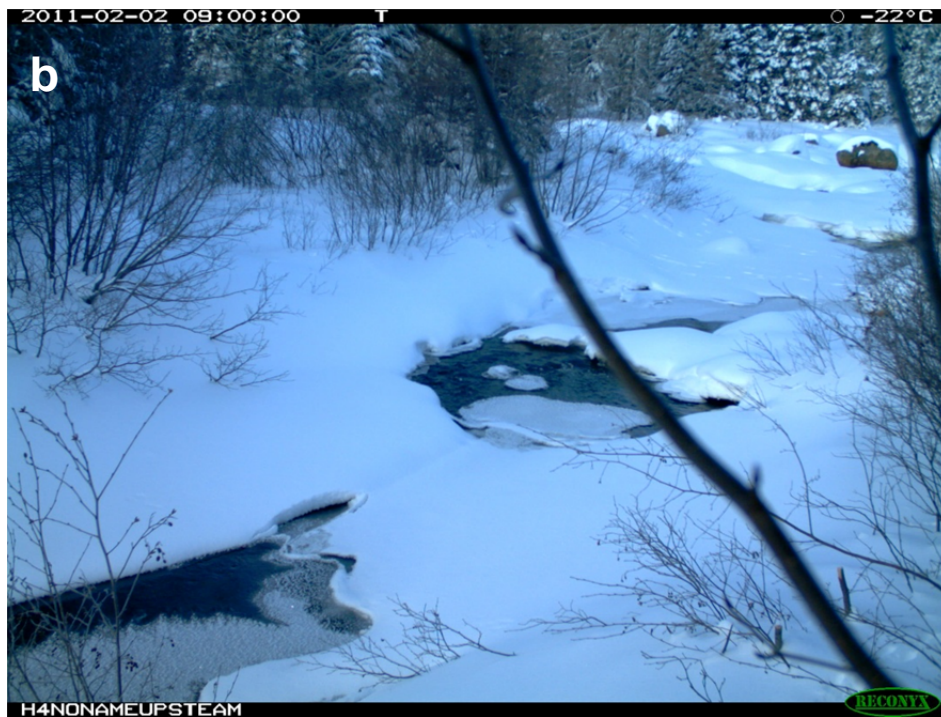
Figure 21. Ice observation photographs from the upstream site on the unnamed creek (unregulated) taken by camera H4 showing: a) first permanent ice on 12-Jan-11; and b) floating frazil on 2-Feb-11.

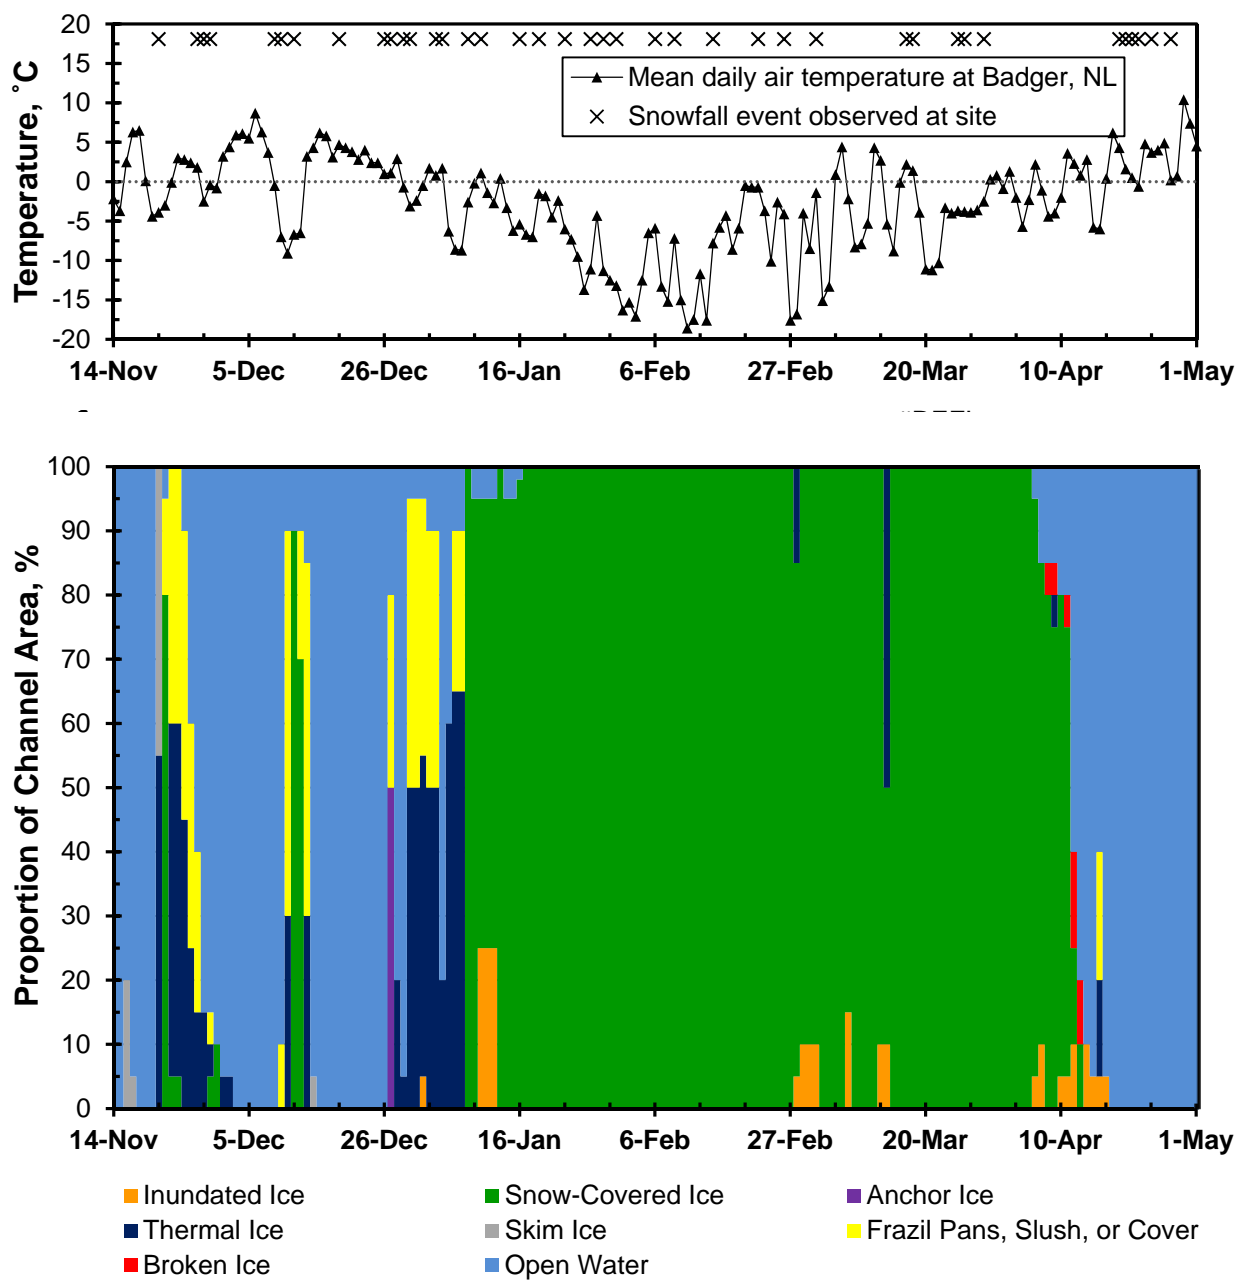
Figure 22. Ice conditions at No Name Creek (unregulated) downstream site for winter 2010-2011 (cameras R4 and M6).

The downstream study reach on the unnamed creek was much wider than the upstream reach, consisting of a large pool upstream of an area with many large emergent boulders and an island with willows growing on it. As Figure 22 illustrates, freeze-up at this site involved many different ice processes. Skim ice first formed between the boulders and growing from pool margins on 16-Nov (mean daily air temperature: 2.5°C, daily minimum: -3.2°C). This ice melted and then skim ice and thermal ice formed 21-Nov, which melted by 3-Dec. Overnight 11/12-Dec (the coldest period in that month: mean daily air temperature -9.1°C) the channel was covered with thermal and floating frazil ice. During that night a frazil ice stopping front was observed passing by the view of the camera. This ice had melted by 16-Dec. Overnight on 26/27-Dec, anchor ice formed at the emergent boulders and the borders of the pool, forming a possible ice blockage on the camera side of the island (Figure 23a). The space upstream of the anchor ice then filled with floating frazil slush. The ice then melted out over the course of 28-Dec. Thermal border ice re-formed on 29-Dec and frazil ice filled the space between the border ice. The channel was completely covered by 8-Jan (Figure 23b). This ice cover stayed largely intact from 17-Jan to 5-Apr. On 6-Apr, water levels rose enough to inundate a portion of the ice cover. The ice then began to crack and broken ice was visible in the open sections of the stream starting 8-Apr. Most of the winter ice cleared out of the observed reach on 13-Apr. On 16-Apr, new border ice and frazil slush were observed, but melted within 1 day. The channel was permanently ice free on 18-Apr, after which mean daily temperatures below 0°C were observed only once more (22-Apr at -0.6°C).

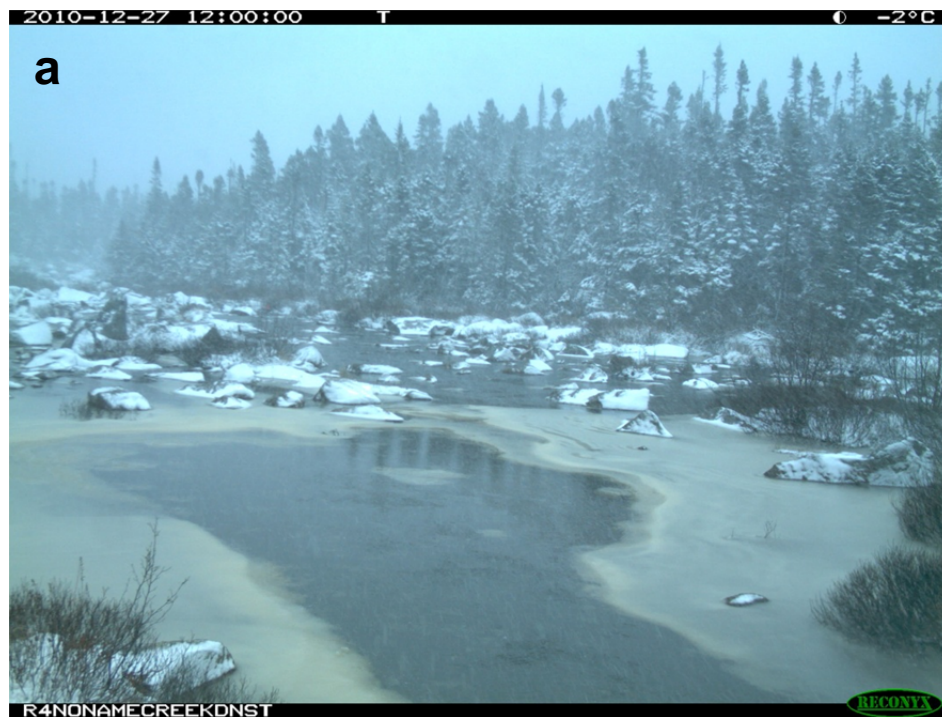
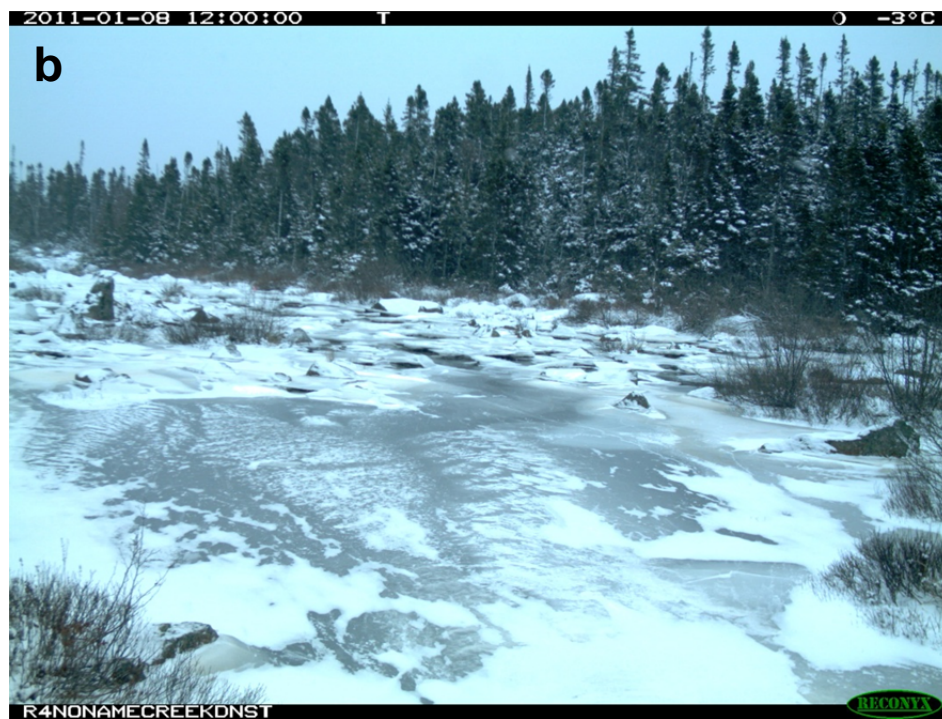
Figure 23. Ice observation photographs from the downstream site on the unnamed creek (unregulated) taken by camera R4 showing: a) anchor ice on 27-Dec-11; and b) ice cover on 8-Jan-11.

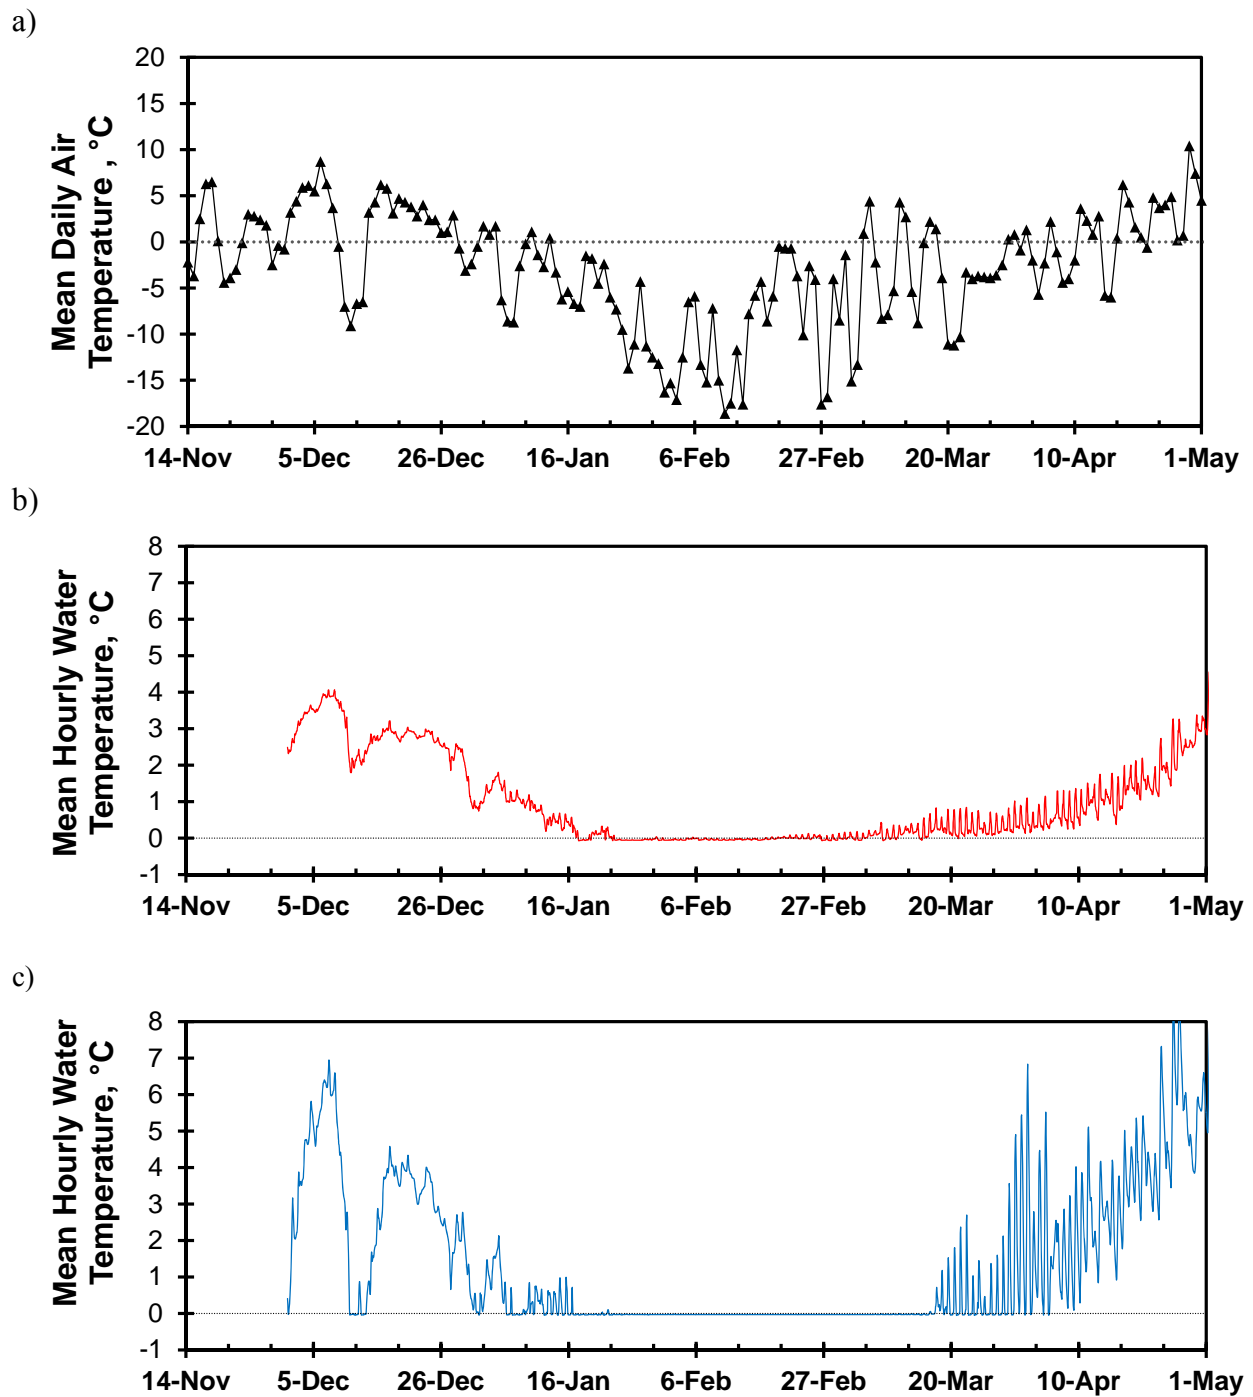
Figure 24. Comparison of: a) air temperature measured at Badger, NL and water temperatures measured at: b) West Salmon River, a regulated stream and c) Twillick Brook, a natural flow stream, for winter 2010-2011.

A comparison of the water temperature data from the West Salmon River and Twillick Brook (Figure 24) suggests that the regulated stream is likely influenced by releases of warm water from the reservoir. For example, the water temperature at Twillick Brook responded more dramatically to cold air temperatures (i.e. 11- to 13-Dec and 5- to 7-Jan) than did water temperatures in the West Salmon River. Also, the water temperature at Twillick Brook reduced to ~0°C, 38 days before the water temperature at the West Salmon River reduced to ~0°C. Moreover, during breakup, the Twillick Brook water temperature displayed much larger daily fluctuations and rose more quickly than that at West Salmon River. No water temperature data was available for the Granite Canal sites. Figure 25, which shows the accumulated degree days of freezing at the time each site first formed a permanent ice cover, also supports this assertion. Specifically, the West Salmon River (regulated) required more degree days of freezing to form a permanent ice cover in than did Twillick Brook (unregulated), implying a thermal influence from Cold Spring Pond. The number of accumulated degree days of freezing required to form a permanent ice cover on Compensation Creek (regulated) was between those required for the two unnamed creek sites. This suggests that differences in channel morphology may have a greater effect than flow regulation on ice conditions.

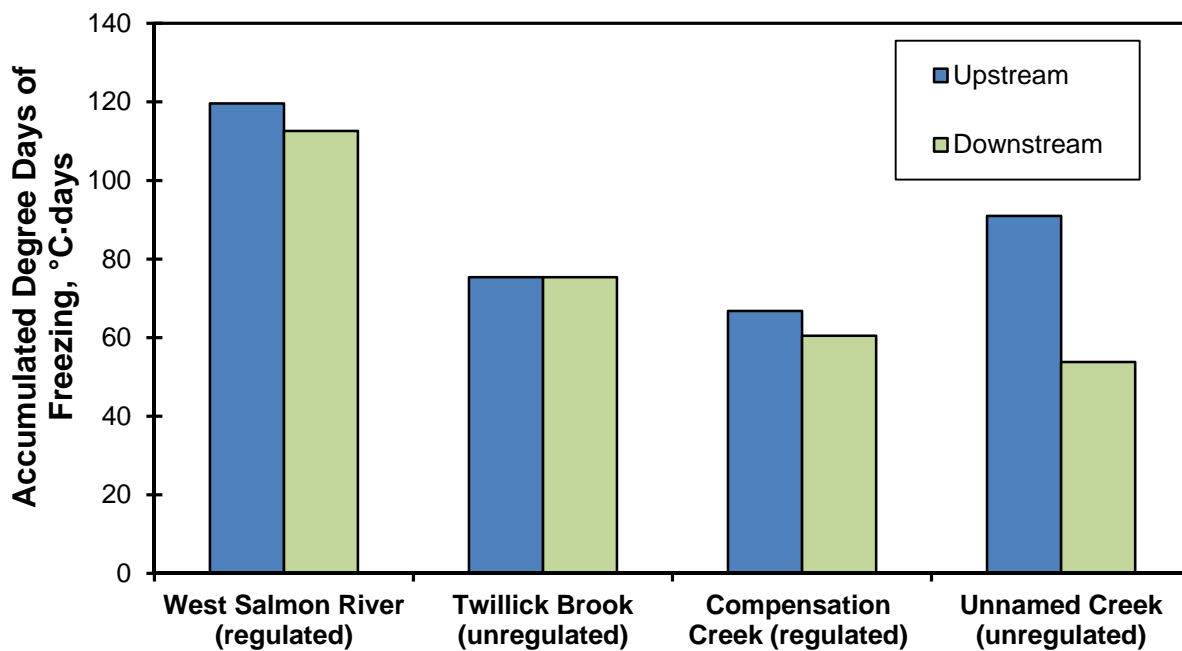
Figure 25. Accumulated degree days of freezing at Badger, NL when first permanent ice forms at each stream.

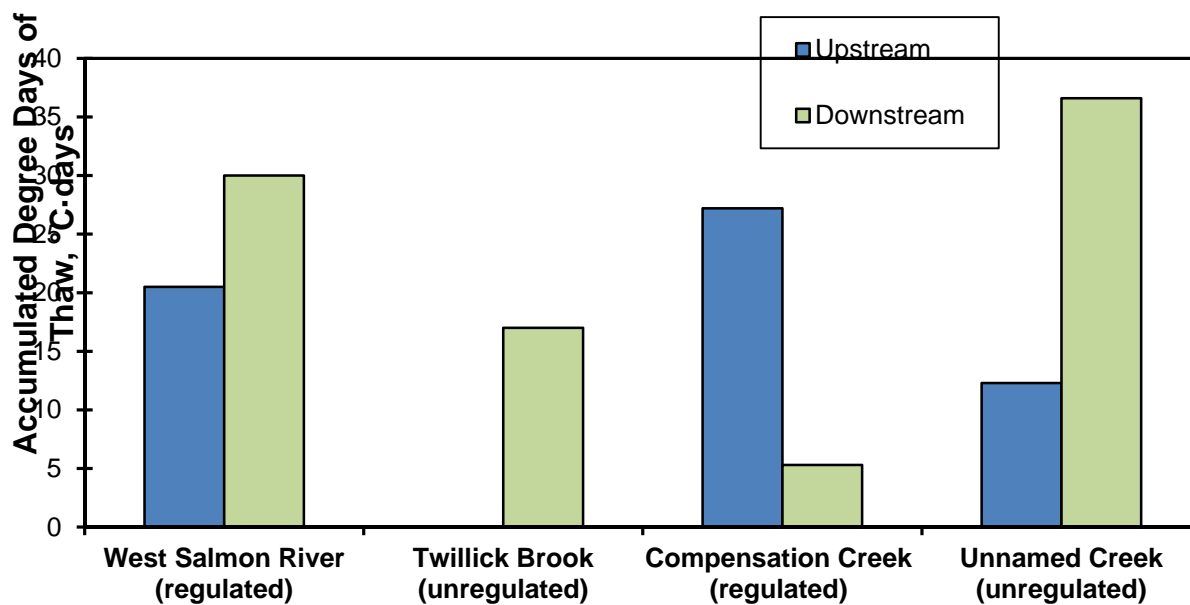
Figure 26. Accumulated degree days of thaw at Badger, NL when streams are first ice free.

The thermal effects of regulation on these streams can also be seen by comparing the accumulated degree days of thaw at which the stream was entirely ice free (Figure 26) and the

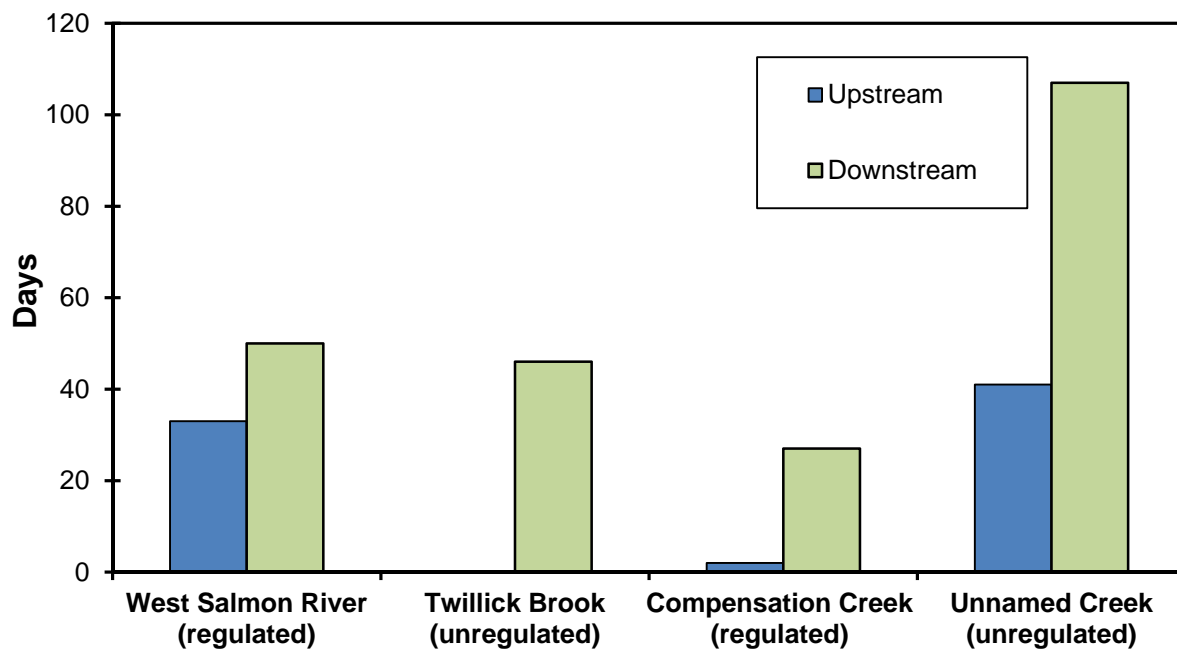
Figure 27. Number of days of $\geq 90\%$ ice coverage at each site.

number of days each site was $\geq 90\%$ ice covered (Figure 27). On the West Salmon River (regulated), the upstream site was ice free before the downstream site and it also was ice covered for a shorter period of time. On Compensation Creek (regulated), the upstream site formed a permanent ice cover before the downstream site, but the upstream site did not completely freeze over and had a 90% ice cover for only 2 days. This suggests that the upstream sites were more affected by the thermal effects of the reservoirs than were the downstream sites (i.e. that the thermal effects were attenuated along regulated streams). These longitudinal differences were more pronounced at breakup than they were at freeze-up. Here also, no clear trend emerges when comparing the accumulated degree days of thaw between Compensation Creek (regulated) and the unnamed creek (unregulated). However, Compensation Creek (regulated) was ice covered for fewer days (14.5 average) than was the unregulated unnamed creek (74 days average), suggesting thermal effects on the regulated stream.
